# G1000 / GFC 700 System Maintenance Manual Hawker Beechcraft Model 200/B200 Series King Air

Contains Instructions  
For Continued Airworthiness  
For STC SA01535WI-D

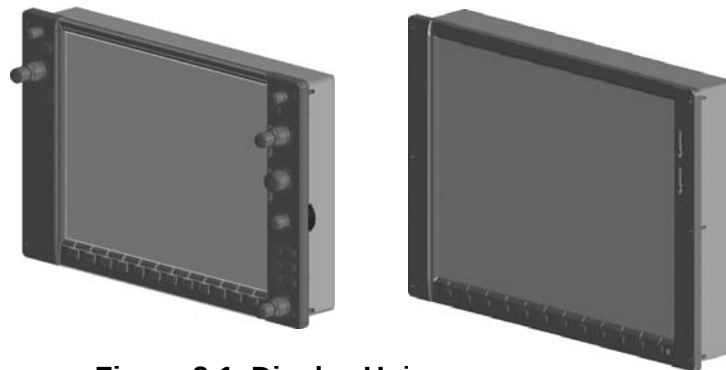
**Figure 2-1, Display Units**

All displays are installed in the King Air panel using ¼-turn fasteners. Three CDU cooling fans are also installed behind the panel for PFD and MFD cooling.

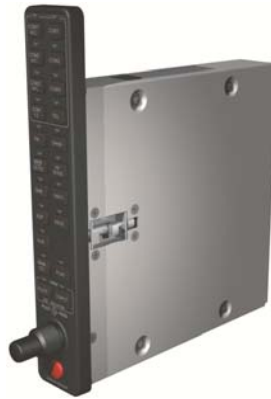
**Figure 2-2, Audio Panel**

The Garmin GMA 1347D Audio Panel integrates NAV/COM digital audio, intercom system and marker beacon controls. The 200/B200 installation includes two GMA 1347D panels. The GMA 1347D panels provide control of all cockpit intercom/mic systems as well as NAV/COM/ILS audio. The units also provide display reversion mode control through a large red button. Warning and alert audio received by the GMA 1347Ds is processed by and received from the GIA 63W Integrated Avionics Units (IAUs). Electrical power to GMA 1 is provided from the Essential bus. Electrical power to GMA 2 is provided from Avionics Bus No. 1. GMA 1 will be powered immediately with external or aircraft power or battery operation. GMA 2 will operate after selecting Avionics Master on. The GMA 1347D units interface with the existing marker beacon antenna, as well as existing mic and phone jacks and oxygen mask mic.

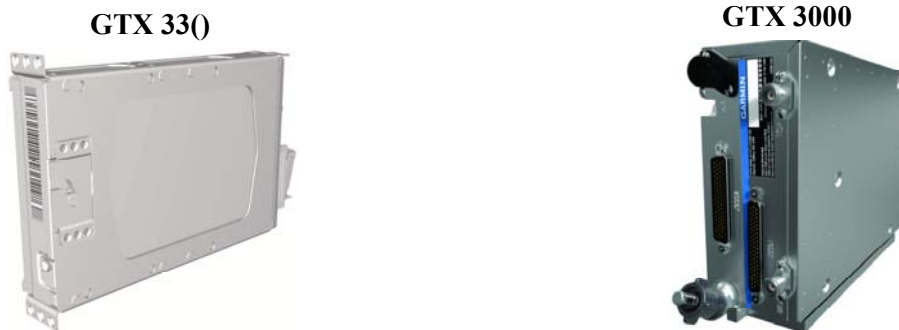
Figure 2-5, Transponder

Power is provided by the No. 1 GTX from the Essential Bus. The No. 2 GTX is powered from the Avionics Bus No. 1. All GTX transponders (non-diversity and diversity) interface with a transponder antenna mounted to the bottom of the fuselage. Each GTX diversity transponder (GTX33D and GTX 3000) interfaces to a transponder antenna mounted to the top of the fuselage.

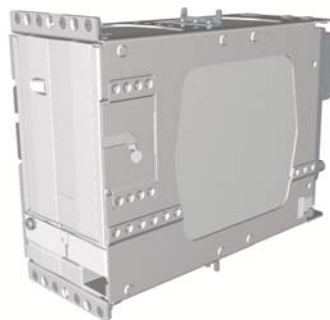
**Figure 2-6, GIA unit**

The GIA 63W #2 interfaces to the following additional equipment:

- GDC 74B #2
- GTX 33 ( ) or GTX 3000 #2
- ADF (if installed)
- Stormscope (if installed)
- Radar Altimeter (if installed)

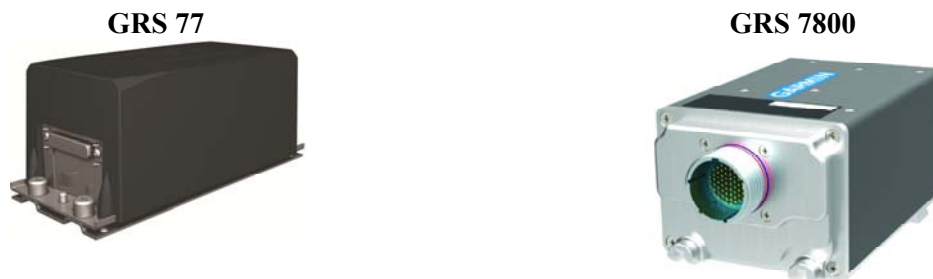
Figure 2-10, AHRS

GRS 1 receives primary electrical power from the Essential Bus and a secondary power supply from the Dual Fed No. 1 Bus. GRS 2 receives electrical power from Dual Fed No. 2 bus.

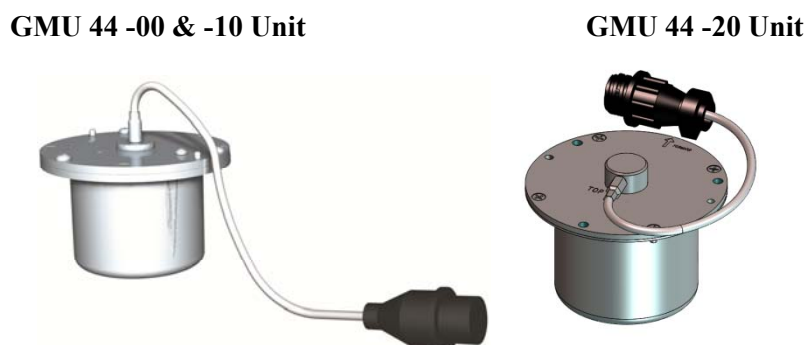
Figure 2-11, Magnetometer

The GMU 44 provides horizontal and vertical magnetic field information to the GRS AHRS. This allows heading to be calculated and provides assistance during AHRS alignment. The GMU 44 units are mounted in the tailcone or in the horizontal stabilizer. The 011-00870-20 GMU 44 units may only be installed in the horizontal stabilizer. The GMU 44 units were modified to account for low clearance installations and have a 90-degree pig-tail harness versus the straight harness on the 011-08870-10 GMU 44 units. The units receive power directly from the GRS units and communicate with the GRS units via RS-485 digital interface.

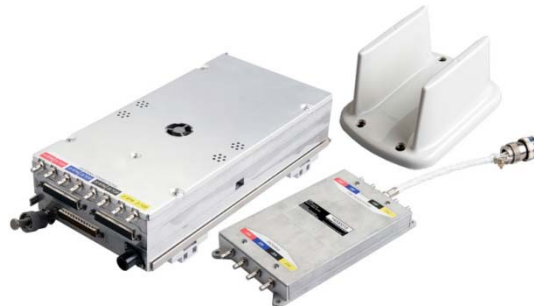
**Figure 2-15, GTS 820/850 Traffic System**

The GTS 820/850 is a traffic surveillance system that uses active interrogation of Mode S and Mode C transponders to provide traffic advisories to the pilot. The GTS 820 is a TAS unit; the GTS 850 is a TCAS I unit. The installation includes a top directional antenna (GA 58) paired with a GPA 65 power amplifier / low noise amplifier (PA/LNA) unit and a bottom, unamplified GA 58 antenna. The GTS 820/850 is located in the nose avionics bay on the top, left shelf. The GPA 65 is located in the left sidewall area, just in front of the most forward cabin window. The GTS 820/850 traffic system is powered from the Avionics No. 2 bus.

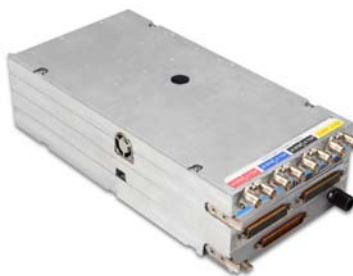
**Figure 2-16, GTS Traffic Processor**

The GTS Traffic Processor is a microprocessor-based Line Replaceable Unit that uses active interrogations of Mode S and Mode A/C transponders to provide Traffic Advisories and Resolution Advisories (GTS 8000 only) to the pilot. When installed, the GTS Processor can be configured as TAS (GTS 825), TCAS I (GTS 855), or TCAS II (GTS 8000). The GTS traffic processor is installed in the nose avionics bay. The GTS interfaces to the GA58 traffic antennas which are mounted on the upper and lower fuselage. The GTS traffic processor also interfaces with the GTX 3000 through ARINC 429 digital data lines. The GTS traffic processor is powered from the Avionics No. 2 Bus.

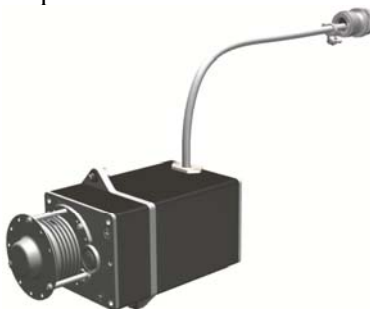
**Figure 2-18, Servo**

The Garmin GFC 700 AFCS uses GSA 80 high torque servos to automatically control aircraft pitch, roll, yaw damper/turn coordination and pitch trim. The pitch trim variant of the GSA 80 is a high speed servo actuator. The GSA 80 contains a motor-control and monitor circuit board, as well as a solenoid and a brushless DC motor. The GSA 80 servo receives serial RS-485 data packets from the GIA 63Ws. The roll servo is located in the forward cabin lower fuselage at F.S. 185. The pitch, yaw, and pitch trim servos are located in the tail. Power to the servos is received from the avionics No. 2 bus. All servos mount to a Garmin GSM 85A or GSM 86 Servo Gearbox. The GSM 85A/86 is responsible for transferring the output torque of the GSA 80 servo actuators to the mechanical flight control surface linkage. The GSM 85A has a slip clutch that can be adjusted to a desired torque value. The GSM 86 has a clutch cartridge that cannot be adjusted to a different torque value.

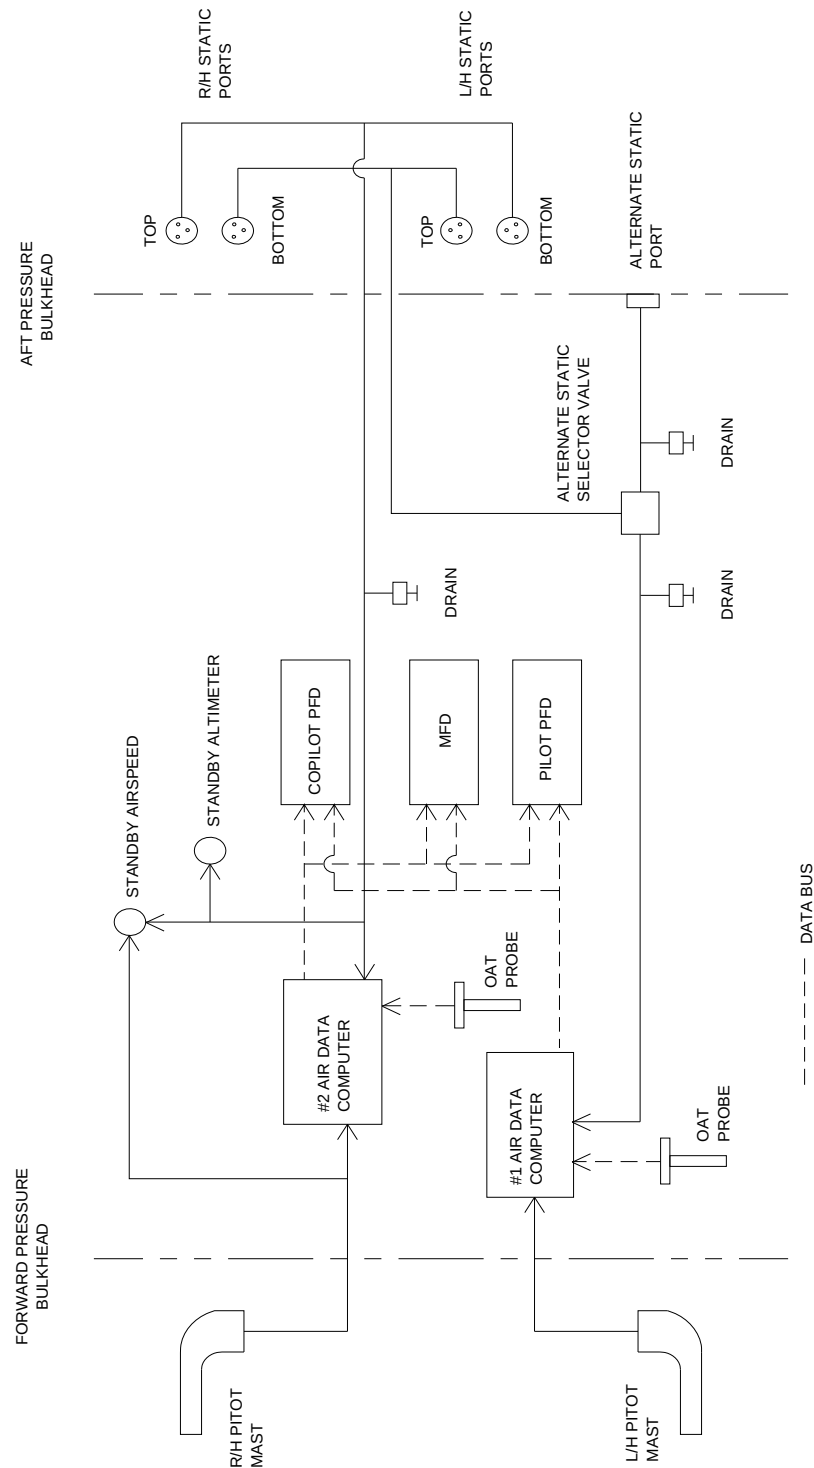
**Figure 2-22, Pitot/Static System (Post G1000 STC)**

The following schematic shows the pitot-static system as modified by this installation:

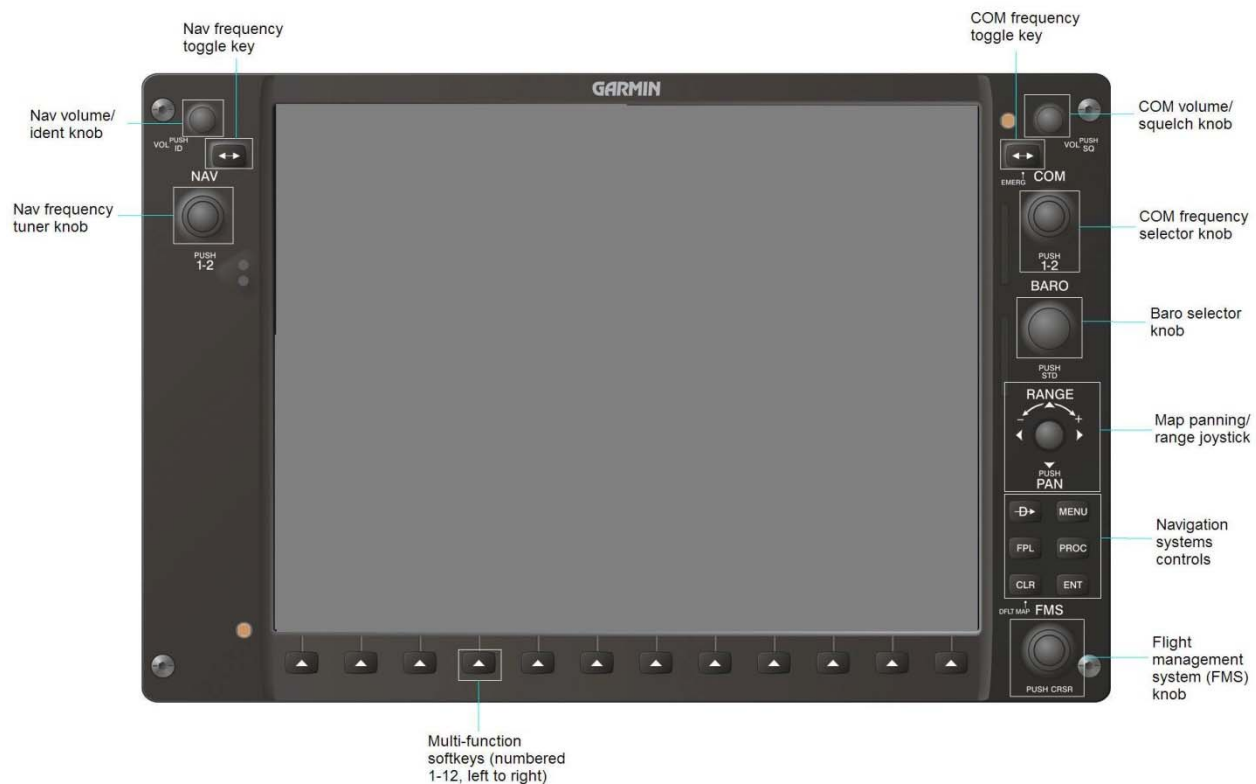
**Figure 3-1, GDU 1040A Control Interface**

Figure 3-1 and Figure 3-2 provide identification of the GDU 1040A PFD and GDU 1500 MFD controls.

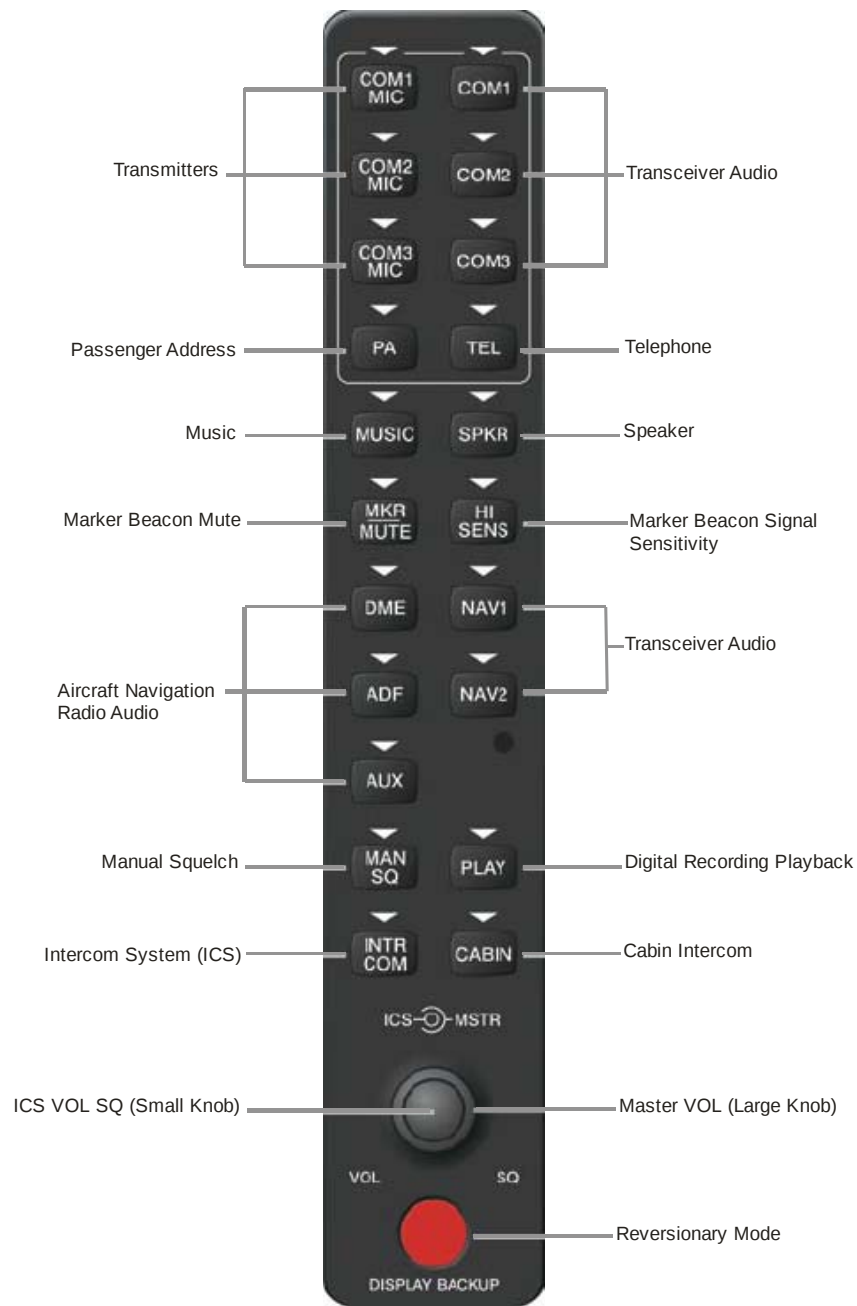
**Figure 3-6, GMA 1347D Controls**

Figure 3-6 provides the audio panel controls.

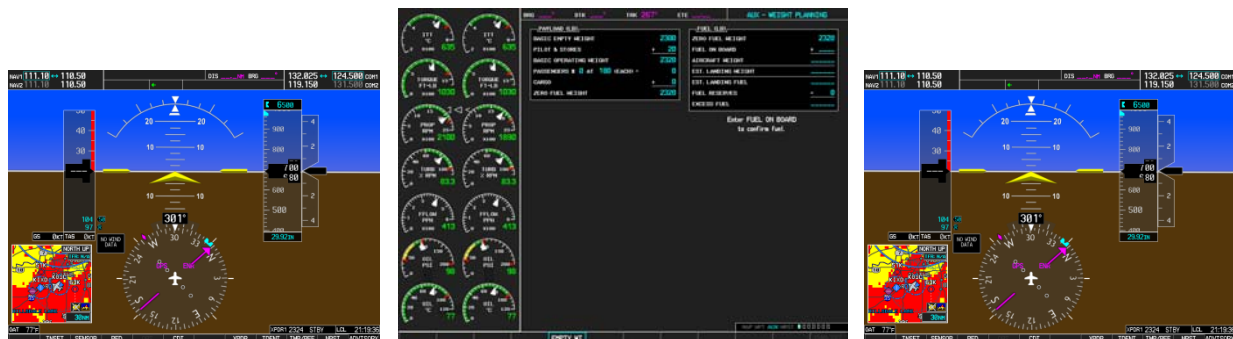
Figure 3-7, Normal Mode

The G1000 system is now powered in the normal mode. In the normal operating mode, data fields that are invalid have large red X's through them. A valid field does not display a red X. Allow the displays to initialize for approximately one minute. The GDC 74Bs requires a longer initialization period than do the other LRUs. During normal operation, this causes the airspeed, altitude, vertical speed, and OAT fields to be invalid during the first ~40-60 seconds of PFD power-up. The PFDs and MFD will function as specified in the G1000 200/B200 Series Cockpit Reference Guide when the system has been correctly installed and configured.

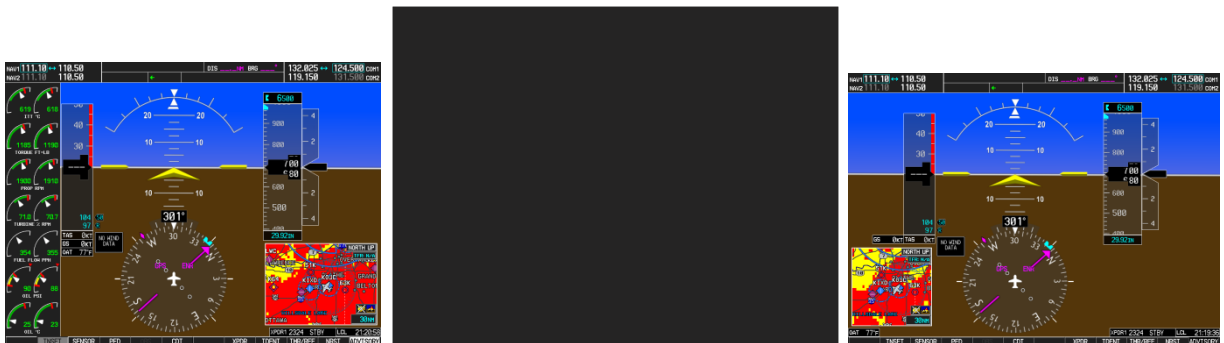
Figure 3-8, Automatic Reversion with MFD failure

Reversionary mode allows for display of information related to safe flight in the event of a display communication or hardware failure. For software version 0985.04 and later, the pilot's PFD automatically goes into reversionary mode when communication to the MFD is lost. Manual reversionary mode allows the operator to force the pilot or copilot's PFD into reversionary mode by pressing the large red button labeled 'DISPLAY BACKUP' on the respective GMA 1347D audio panel.

When the 'DISPLAY BACKUP' button is pushed to exit reversionary mode, there is a 5-second debounce (or the GDU waits for 5 consecutive seconds) and then returns to normal mode if no other input is received. If the 'DISPLAY BACKUP' button is pushed again during this 5-second interval, the timer will repeat the count.

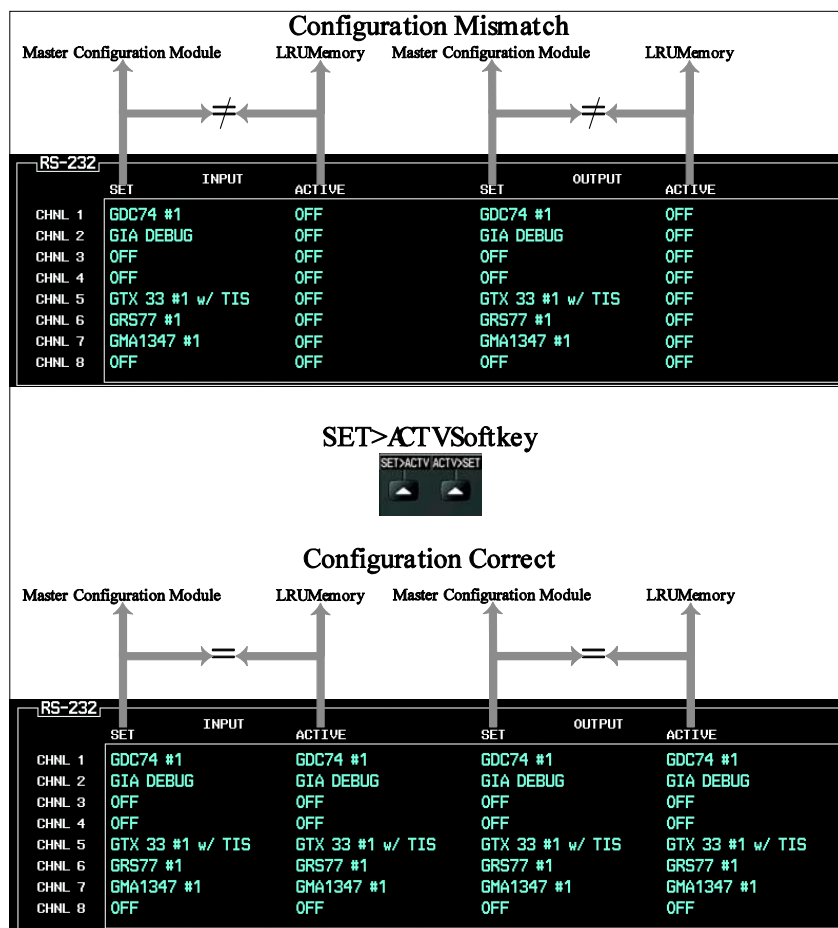
**Figure 3-10, SET>ACTV Diagram**

In the first example shown in Figure 3-10 the SET columns do not match the ACTIVE columns. The inequality between SET and ACTIVE indicates a configuration mismatch. By pressing the SET>ACTV softkey, this copies the SET column to the LRU unit's configuration memory. The settings then become the ACTIVE settings for the LRU being configured.

- SET>ACTV (read 'Set to Active') softkey: Allows the installer to send the information in the SET column (data stored in the master config module) to the ACTV column (data used by LRU).
- ACTV>SET (read 'Active to Set') softkey: Causes the LRUs current settings to be copied to the master configuration module as SET items.

**The ACTV>SET softkey must be used with caution! If an improperly configured unit is installed, this softkey causes the wrong configuration to replace the correct aircraft configuration.**

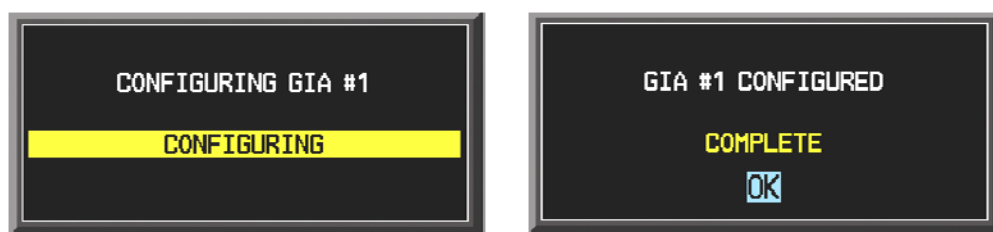
Figure 3-12, Configuration Status

When configuration settings are changed, the technician receives on-screen prompts and/or confirmations such as those shown in Figure 3-12. Section 7 shows other prompts encountered during the configuration process.

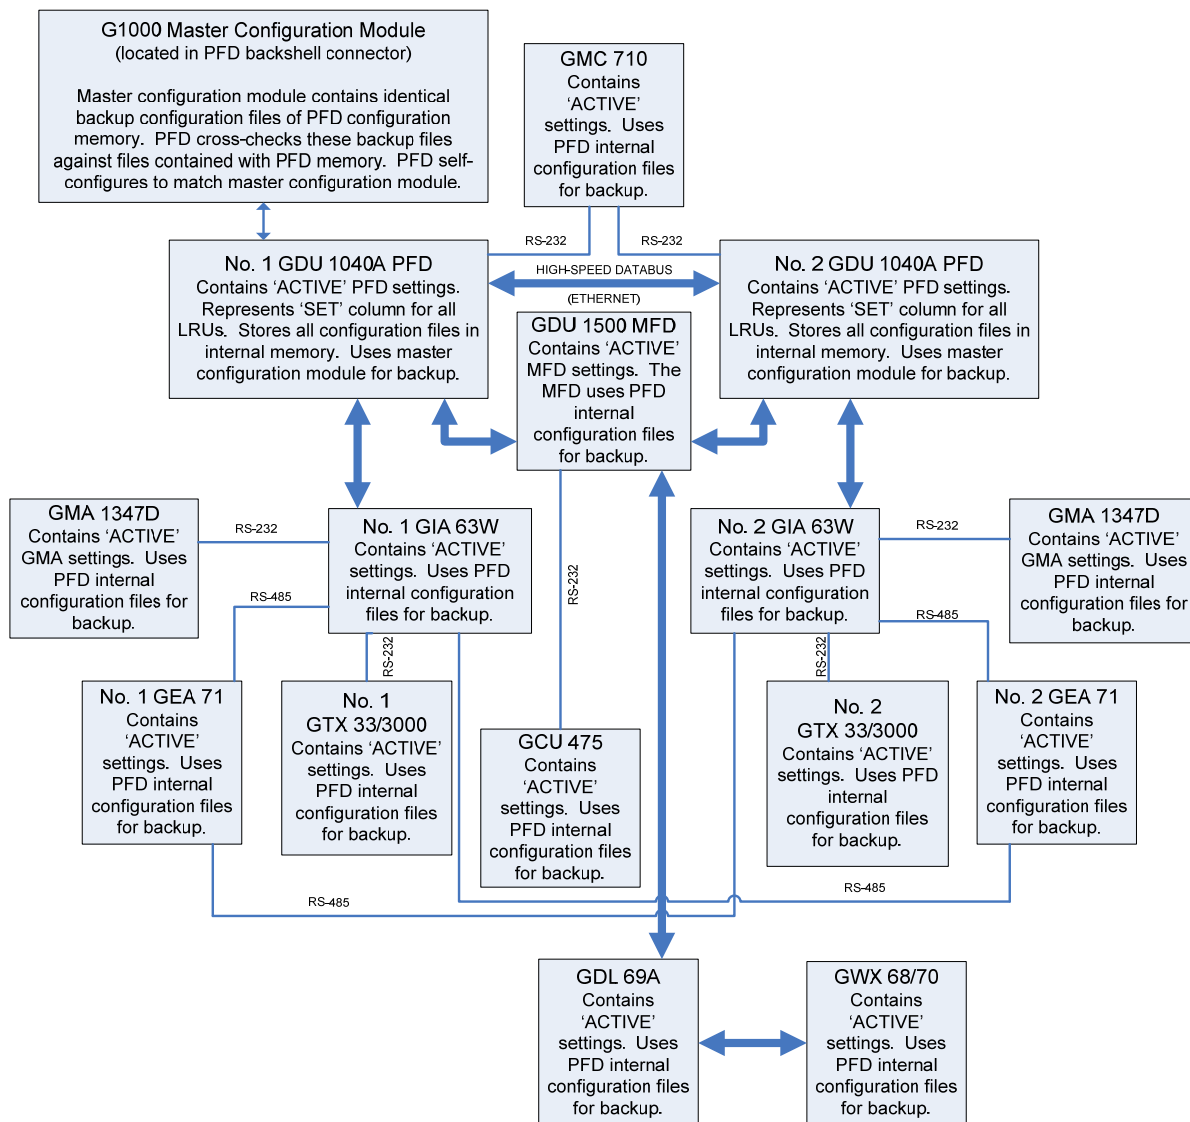
Figure 3-14, G1000 LRU Configuration File Storage

During system configuration, each file is sent directly to the applicable LRU where it is stored in local LRU memory (reference Figure 3-14.). Each file is also stored in the PFD internal memory. The applicable PFD also sends a copy of all configuration files to the 'Master Configuration module', located in the connector backshell (see Section 6.16). If the PFD is replaced, the configuration module retains all configuration files in the aircraft.

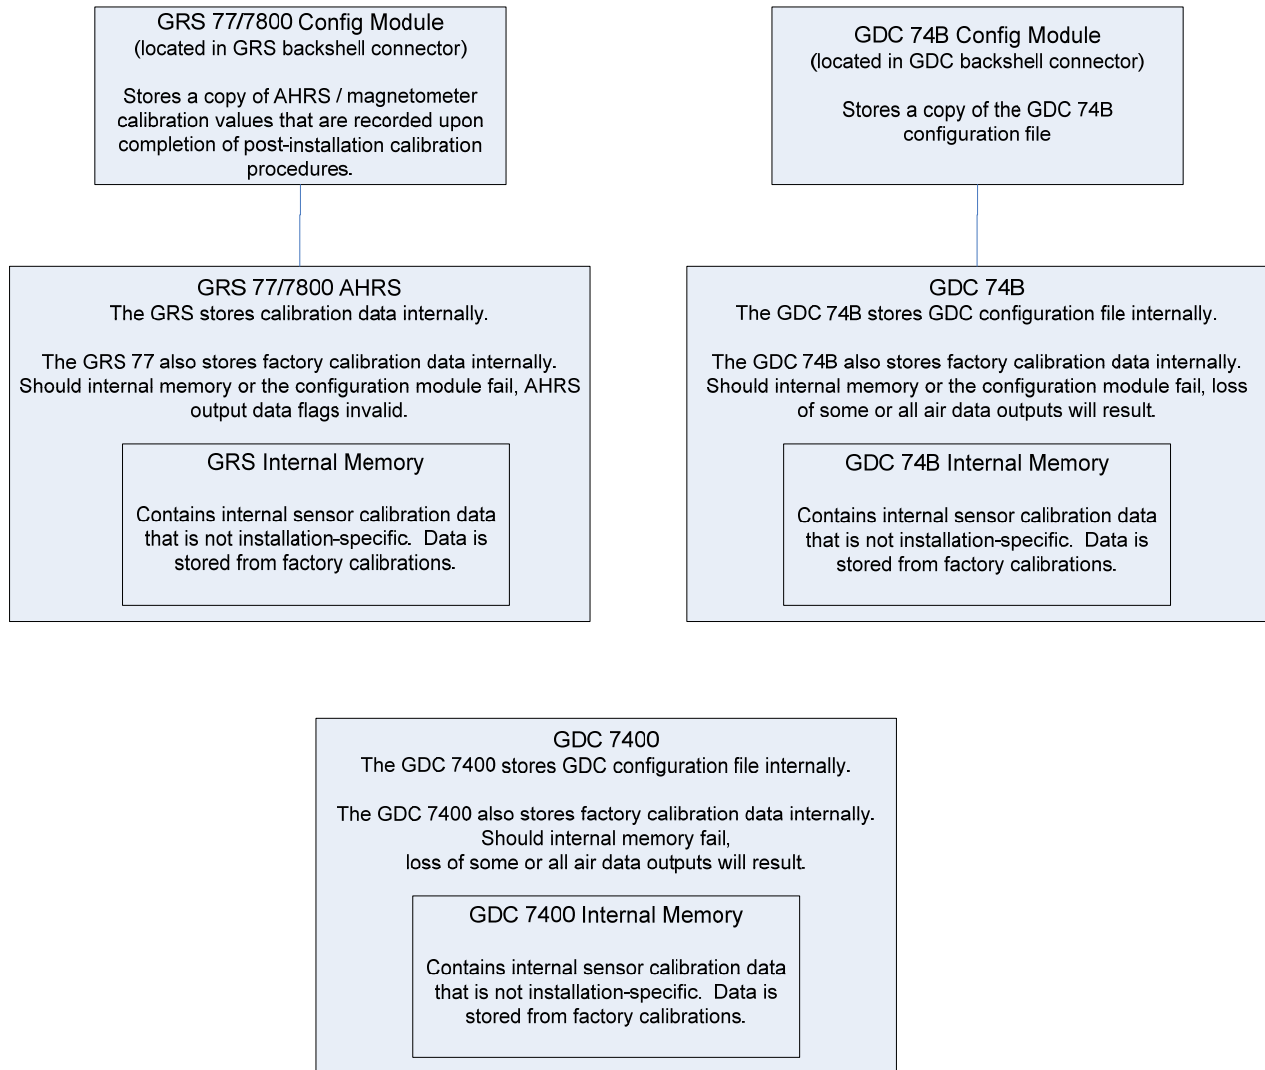
**Figure 3-15, GRS/GDC Configuration Settings Storage**

The GRS 77/7800, GMU 44, GDC 74B and optional GDC 7400 configuration/calibration (reference Figure 3-15) is different than the LRU's shown in Figure 3-14.

The GDC 7400 air data computer configuration file is loaded directly to GDC 7400 internal memory and there is no configuration module for the GDC 7400.

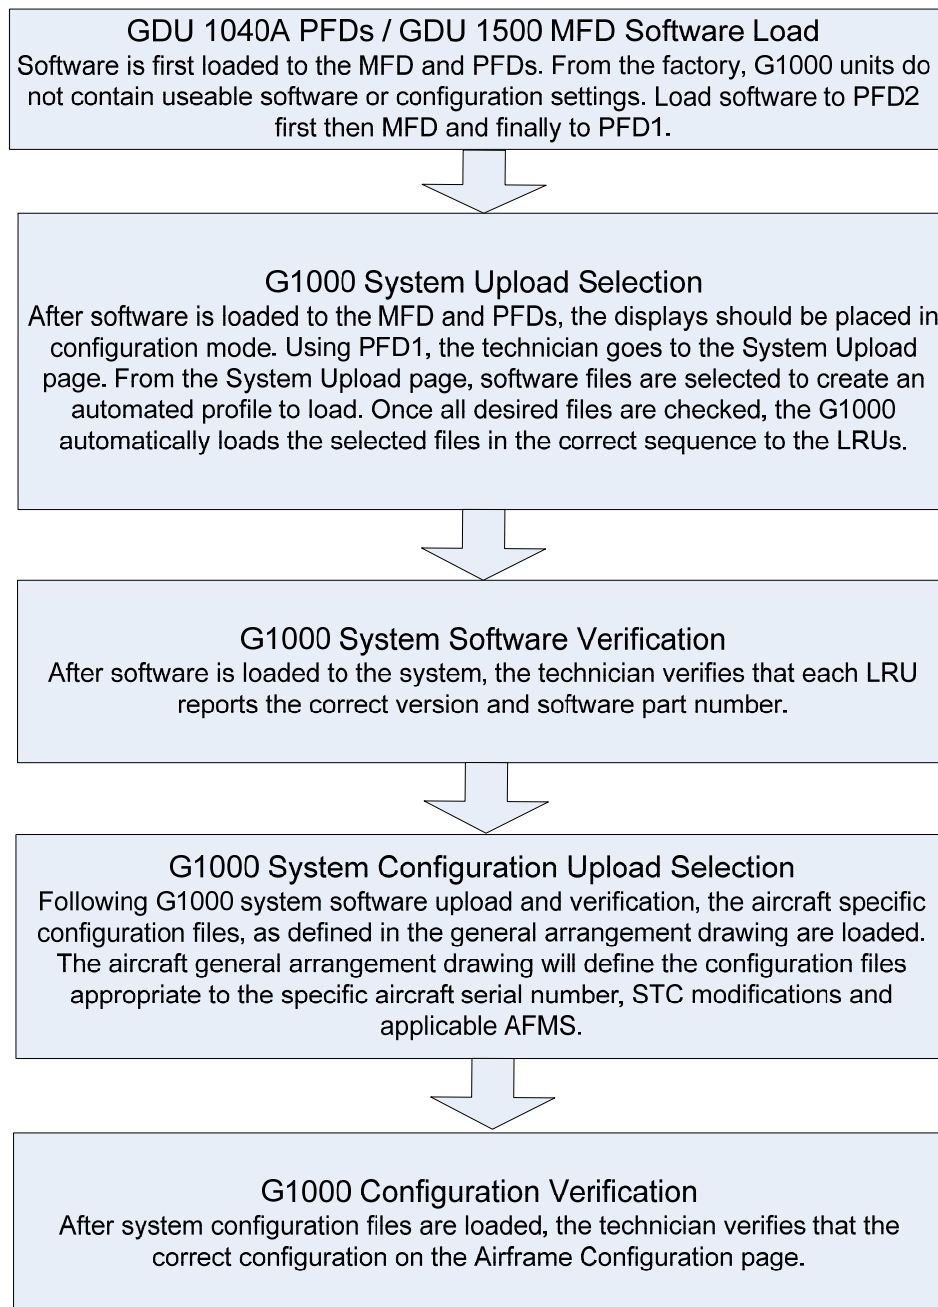
**Figure 3-16, Software/Configuration Overview**

The following diagram depicts an overview of the software/configuration sequence for the G1000 system. This applies mostly to a new G1000 system which has not previously been powered up and is for informative purposes only.

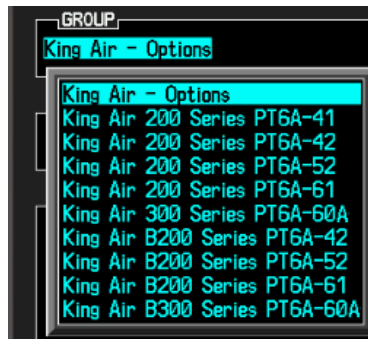
Figure 3-17, Airframe Options

1. Ensure loader card is inserted into top card slot of PFD1. On PFD1, select the “System Upload” page using the PFD1 small FMS knob.
2. Activate the cursor and use the PFD1 small FMS knob to highlight the GROUP field. Scroll small FMS knob to select the appropriate airframe and engine combination. Press the PFD1 ENT key to select the configuration.

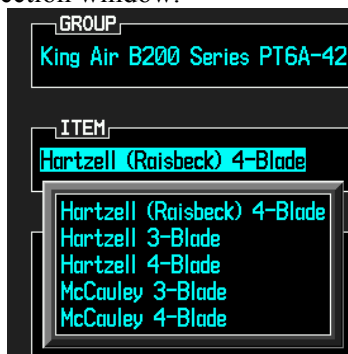
Figure 3-18, Propeller Options

3. Once an airframe type is selected the cursor moves to the ITEM window. Rotate the PFD1 small FMS knob to activate the drop-down menu. Move the cursor to highlight the appropriate propeller configuration for the aircraft and press ENT on PFD1.

Not all propellers are available for selection with each airframe and engine configuration. Only those props that are approved for installation on a particular airframe/engine are available in the drop down selection window.

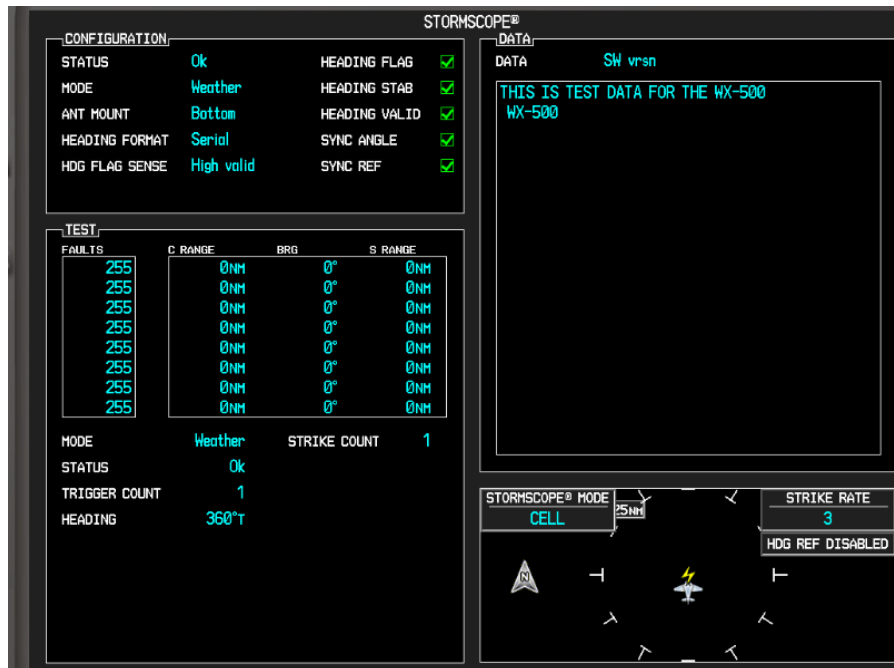
Figure 3-20, Stormscope Configuration Page

1. With PFD1 in configuration mode, use the PFD1 large FMS knob to select OTHER and the Stormscope configuration page.

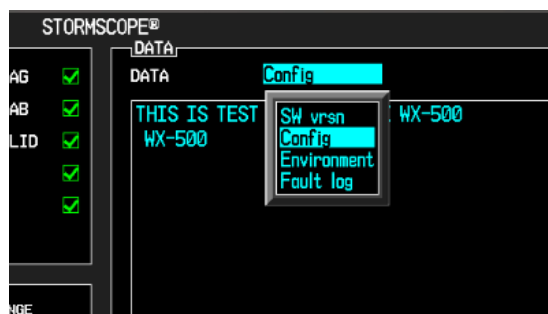
Figure 3-21, Stormscope Configuration

2. Activate the cursor to highlight the DATA field. Use the small FMS knob to open the drop down menu then select ‘Config’ and press ENT key on the PFD1.

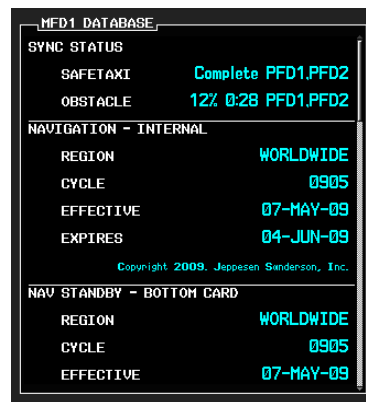
Figure 3-23, Supplemental Database Synchronization

1. Open PFD1, PFD2 and MFD circuit breakers.
2. Remove the SD card containing the supplemental databases from the *lower* slot of the MFD. Supplemental databases include basemap, Safetaxi, airport terrain, obstacle, airport directory and terrain databases.
3. Download the current supplemental databases to the SD card.
4. Reinsert the SD card containing the current supplemental databases into the *lower* slot of the MFD.
5. Close PFD1, PFD2 and MFD circuit breakers.
6. The system will synchronize the data to the PFDs as necessary (FliteCharts and ChartView are located only on the MFD and do not require synchronization.) Monitor the synchronization process on the AUX – SYSTEM STATUS page in the SYNC STATUS sub-section within the DATABASE window. This sub-section is only present when a sync is occurring or has occurred on the current power cycle.

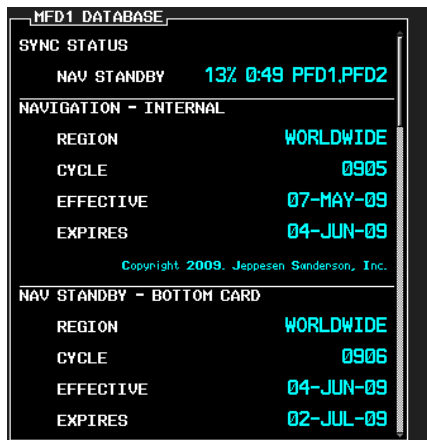
Figure 3-25, Navigation Database Synchronization

7. The system will synchronize and automatically update as necessary. Monitor the synchronization process on the AUX – SYSTEM STATUS page in the SYNC STATUS sub-section within the DATABASE window. This sub-section is only present when a sync is occurring or has occurred on the current power cycle.

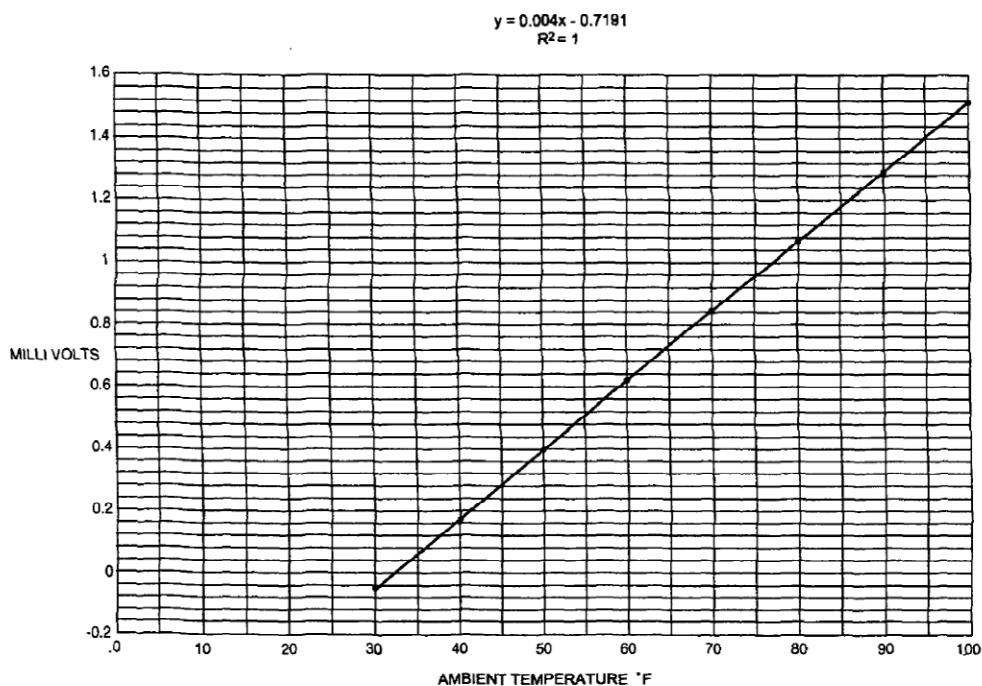
**Figure 4-5, Ambient Temperature Conversion Chart**

4. Apply external power to aircraft and start the G1000 in normal mode.
5. Using the Thermocouple Calibrator (or equivalent), inject the DC signals specified in Table 4-14 and verify the indications are within specified tolerances. If the Thermocouple Calibrator is not temperature compensated, use the chart shown in Figure 4-5 to convert the ambient temperature to millivolts and subtract from Table 4-14.

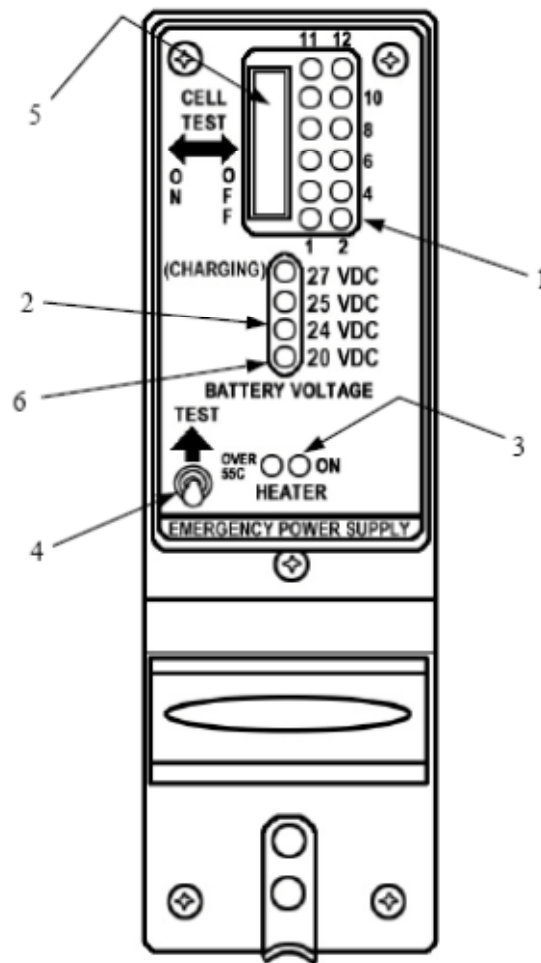
**Figure 4-6, Standby Battery**

- A. Press and hold TEST SWITCH (Figure 4-6, Item 4) and observe the OUTPUT VOLTAGE MONITOR LED's.
  - 1) If the 24VDC OUTPUT VOLTAGE MONITOR LED comes on, proceed with Discharge Test procedure.
  - 2) If OUTPUT VOLTAGE MONITOR LED's do not come on, check fuses at bracket next to battery and replace if blown. Perform Cell Isolation Test if no fuses are blown.
- B. Discharge Test (Load Resistor)
  - 1) Prepare for test by first constructing an X-Y graph similar to the one shown below. If possible, use pre-printed graph paper to create a record of the discharge period along the X-axis and voltage readings along the Y-axis.

- 2) Position all INDIVIDUAL CELL DIP SWITCHES (Figure 4-6, Item 5) to the ON position.  
If the INDIVIDUAL CELL MONITOR LED DS12 is the only LED not illuminated, proceed to the Cell Isolation Test.
- 3) Connect Digital Voltmeter leads to J1 connector pins 11 (+) and 7 (-).
- 4) Connect the Load Resistor across J1 connector pins 11 (+) and 7 (-) and start timing the discharge period with a stopwatch.

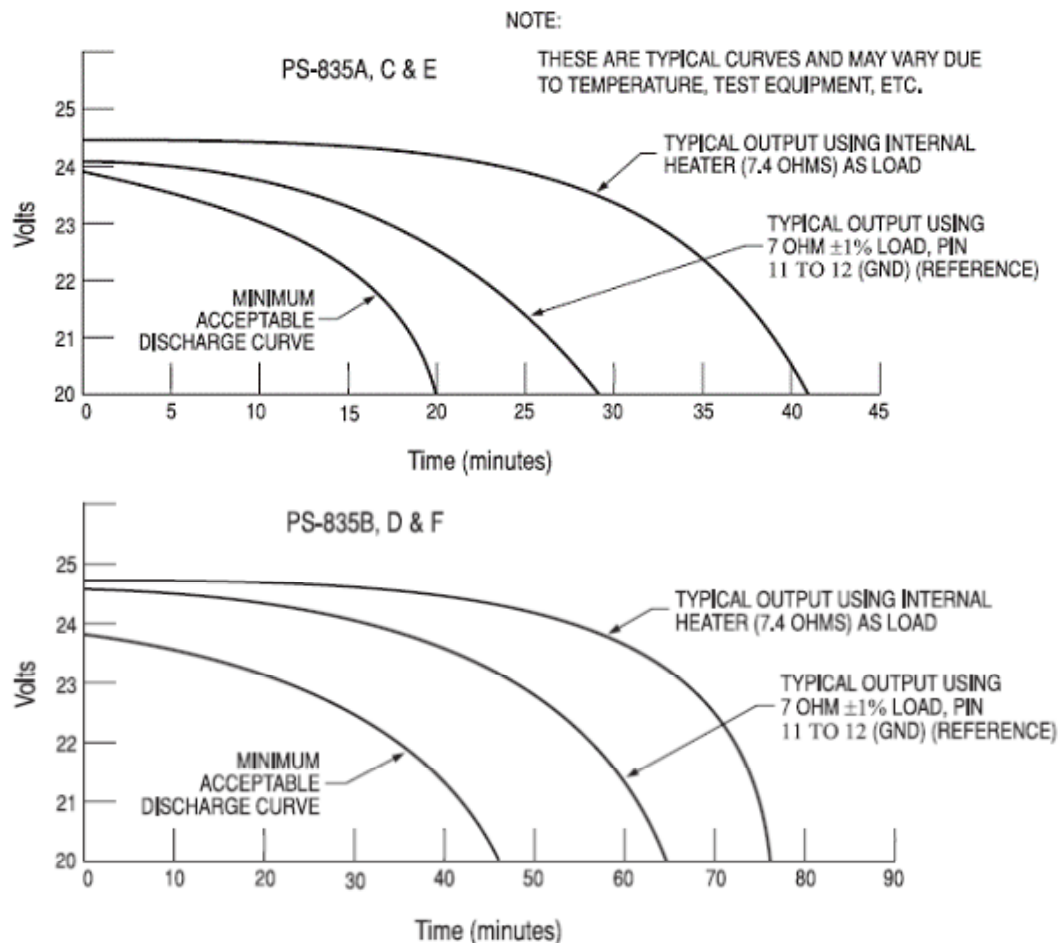
With the PS-835 battery installed in the aircraft and aircraft power applied, verify all four Battery Voltage LEDs are lit to indicate the battery is being charged (see Figure 4-6).

With the PS-835 battery installed in the aircraft and no aircraft power applied, press TEST SWITCH (Figure 4-6, Item 4) into TEST position for 5 seconds. The PS-835 indicates that it is adequately charged when the VOLTAGE LEVEL 24Vdc LED (Figure 4-6, Item 2) illuminates momentarily, AND the 20Vdc LED (Figure 4-6, Item 6) remains lit during the test. If the VOLTAGE LEVEL 24Vdc LED does not, at least momentarily, illuminate while the 20Vdc LED is illuminated, perform the Section 4.16.3 Cell Isolation Test because the battery is incapable of providing adequate power.

- a. All INDIVIDUAL CELL MONITOR LED's (Figure 4-6, Item 1) must remain on.
  - b. Any LED that does go OFF will represent a defective individual cell, which must be replaced.

- 7) Remove the Load Resistor from J1 connector pins 11 (+) and 7 (-).
- 8) Position all INDIVIDUAL CELL DIP SWITCHES (Figure 4-6, Item 5) to the OFF position.

- A. Press and hold TEST SWITCH (Figure 4-6, Item 4). If no OUTPUT VOLTAGE MONITOR LED's come on:
  - 1) Position all INDIVIDUAL CELL DIP SWITCHES (Figure 4-6, Item 5) to the ON position.
  - 2) Press and hold TEST SWITCH (Figure 4-6, Item 4) and observe the INDIVIDUAL CELL MONITOR LED's (Figure 4-6, Item 1).
    - a. If all INDIVIDUAL CELL MONITOR LED's come on except DS12, the unit is damaged and requires repair at an authorized repair station.
    - b. If all INDIVIDUAL CELL MONITOR LED's are on, a low-battery voltage condition exists.
- B. Perform the Charging Procedure.

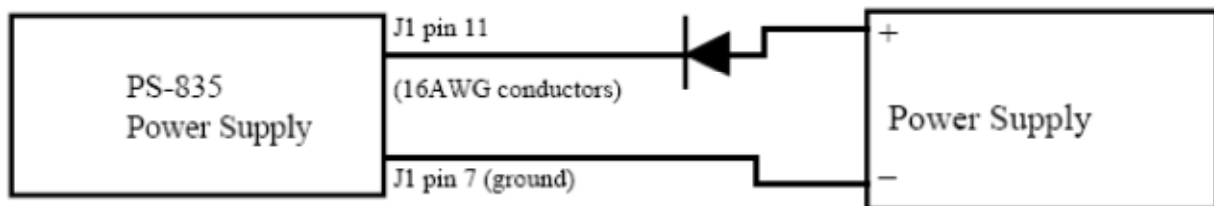
Figure 4-7, Power Supply Connection

Locally manufacture a power cable using 16AWG wire and the appropriate mating connector. Include a Diode (15 Adc (min), 50.0 PIV or greater) to prevent battery discharge in case of loss of power from the power source. Using the external power supply apply 30.0 Vdc (10A maximum current limited) to J1 connector pins 11 (+) and 7 (-) and charge the unit for 16 hours. The batteries should reach 80% capacity within 1 hour and full charge at 16 hours.

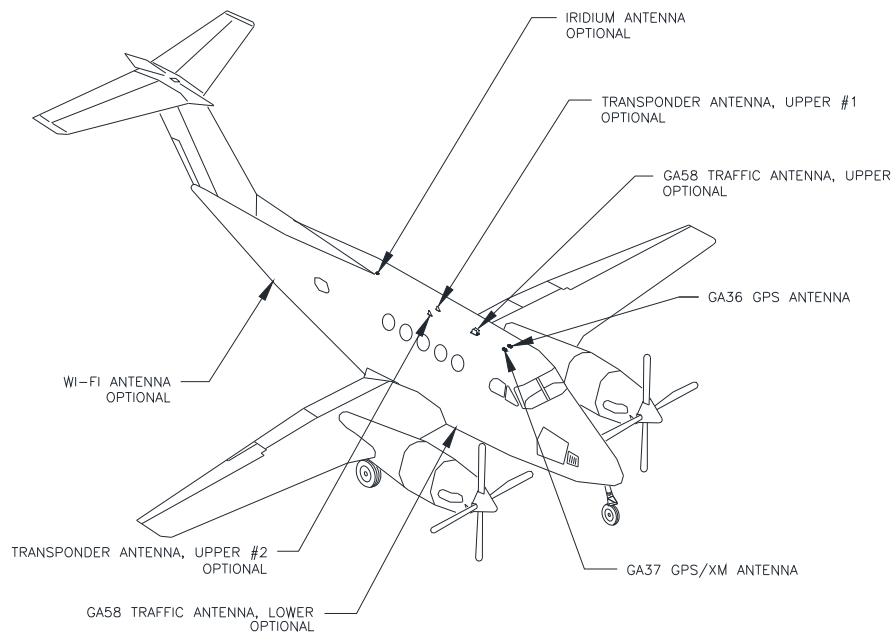
**Figure 4-8, Exterior Skin Inspection Around Antennas**

The antennas do not need to be removed to perform this inspection.

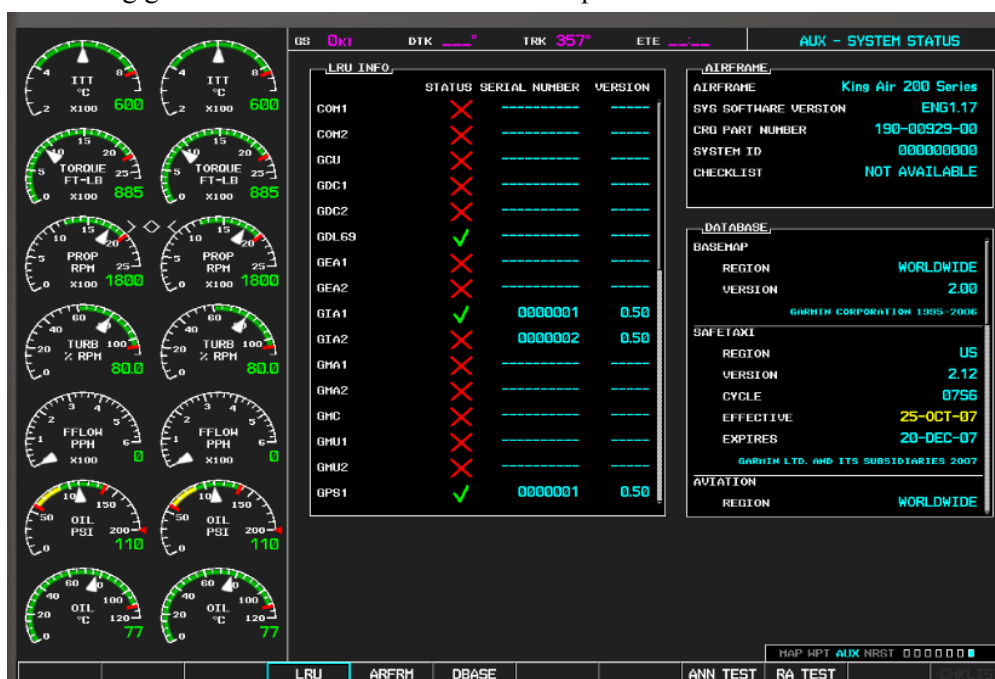
Figure 5-1, AUX – System Status Page

Troubleshoot the G1000 system by first identifying, then isolating the specific failure to the responsible LRU. There are several indications that the G1000 presents to the pilot or technician, showing overall system condition. A course of action should be determined based on the information presented on the display. This section shows possible scenarios likely to be encountered during normal operation and gives troubleshooting guidance to the technician to resolve problems.

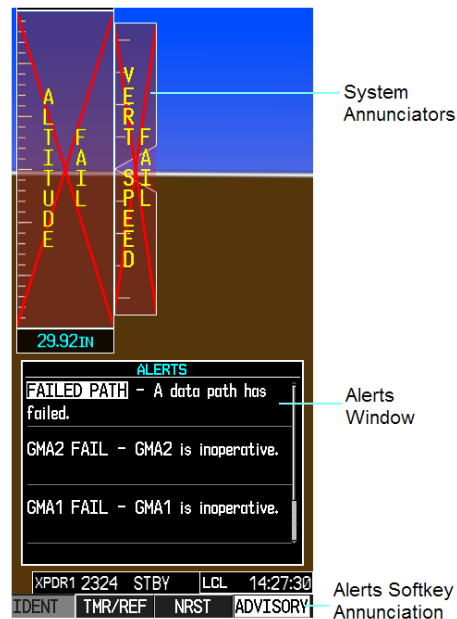
**Figure 5-2, Alerts & Annunciations**

The G1000 Alert System conveys alerts to the pilot using combinations of the following features:

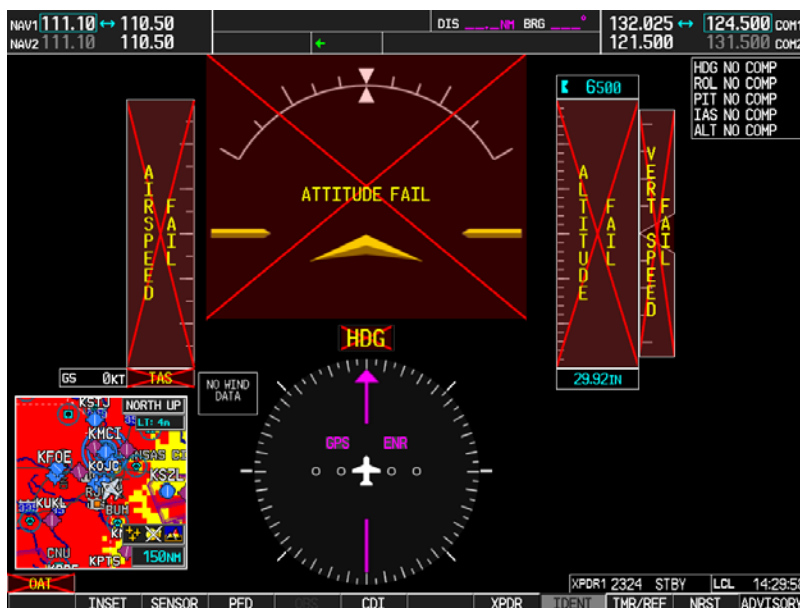
Figure 5-4, System Annunciations

If data fields become invalid due to an LRU failure, the PFD/MFD typically annunciates the failure with a large red X, as shown in Figure 5-4.

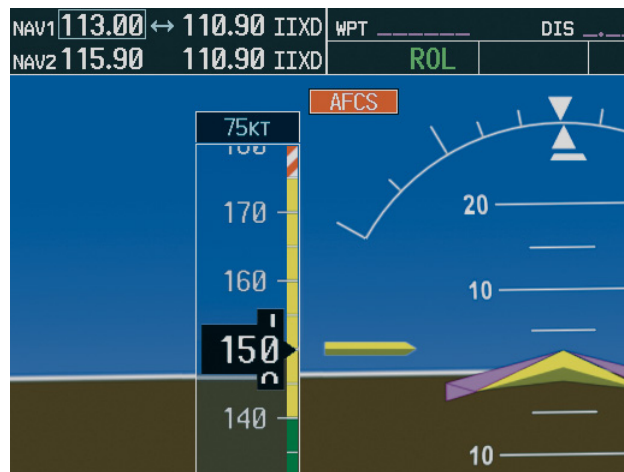
Figure 5-5, AFCS Annunciation Field

The GFC 700 AFCS Annunciation field is located above the airspeed tape on the PFD as shown:

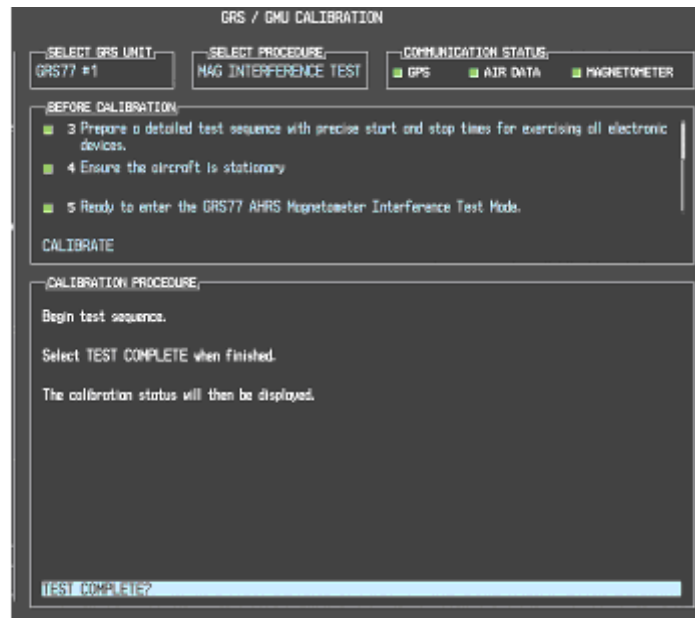
**Figure 5-7, Magnetometer Interference Test**

This test is used to validate that no electronic device or magnetized components produce a magnetic field sufficient to interfere with the operation of the GMU 44 magnetometer. It is highly recommended that this test be performed after installation or maintenance of electrical components on the aircraft and/or for troubleshooting the GMU 44.
