# G1000 / GFC 700 System Maintenance Manual Hawker Beechcraft Model 200/B200 Series King Air

Contains Instructions  
For Continued Airworthiness  
For STC SA01535WI-D

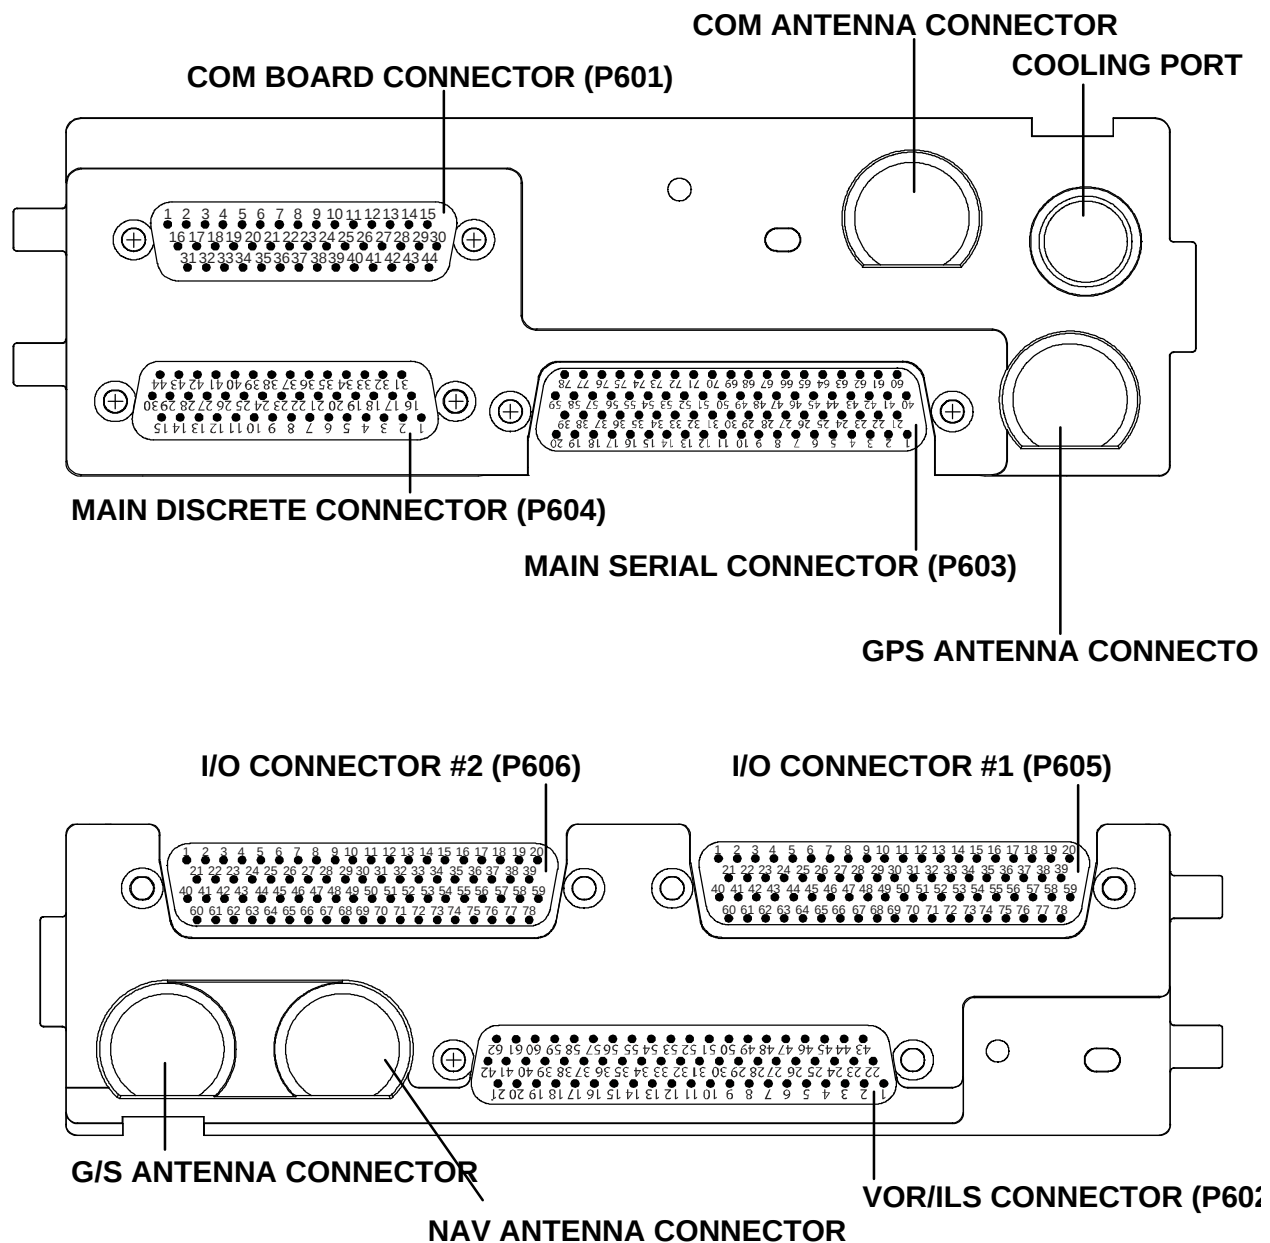
Figure 5-8, GIA 63W Backplate Connectors

The following figures depict the backplate connectors as viewed with the LRU removed.

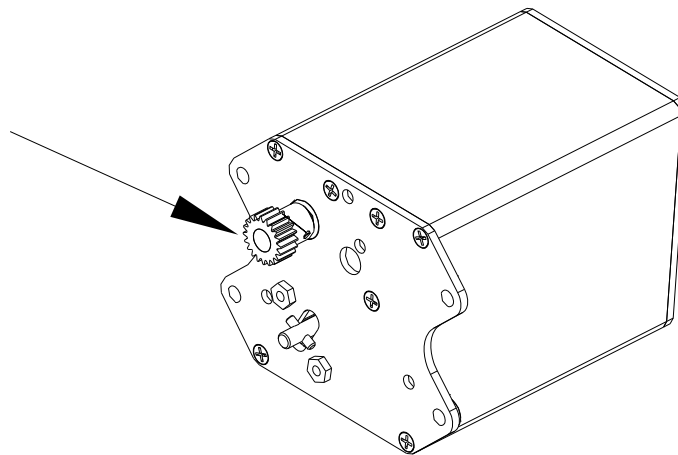
**Figure 6-1, Servo Gear**

3. Using a brush or other applicator, apply a thin coat of Aeroshell 33MS (Lithium-complex based) grease to the servo output gear

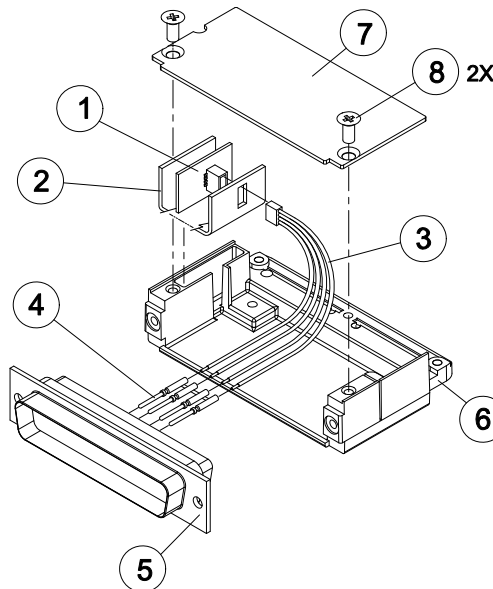
Figure 6-2, Configuration Module Installation

Configuration modules (Reference Figure 6-2 and Table 6-1, Item 1 shown below) are located in the following LRU harness connector backshells (Item 6): GDU 1040A PFD, GRS 77 AHRS, GDC 74B Air Data Computer, and the GEA 71 Engine/Airframe Unit. Additionally, the GRS 7800 has a different configuration module that is located in the GRS 7800 connector backshell. Refer to Section 6.16.2 for the GRS 7800 configuration module removal and replacement instructions. Refer to the Master Drawing List, listed in Table 1-2, for specific installation drawings.

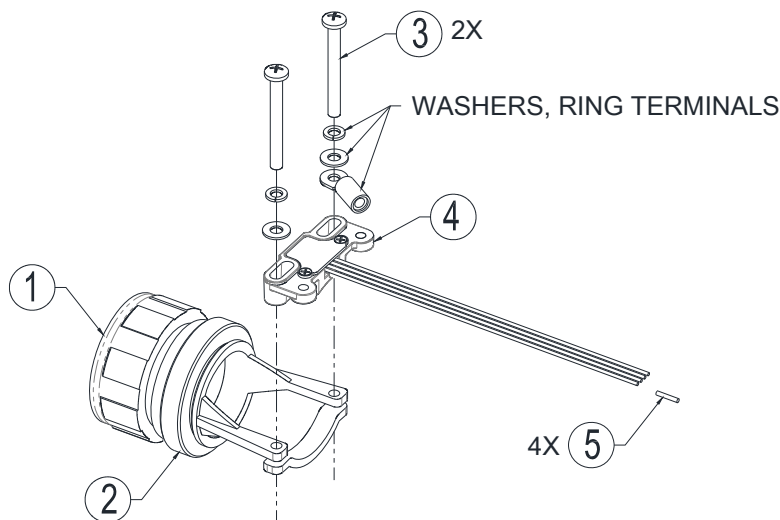
Figure 6-3, GRS 7800 Configuration Module Installation

The GRS 7800 configuration module is located on the LRU harness connector strain relief. Refer to the Master Drawing List, listed in Table 1-2, for specific installation drawings.

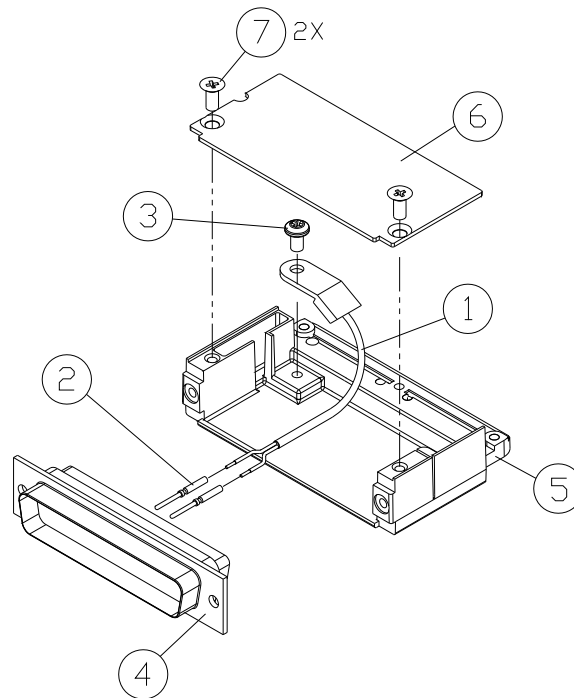
Figure 6-4, GEA Backshell Thermocouple

The GEA 71 has a K-Type thermocouple (Item 1 shown below) installed in its backshell, in addition to the configuration module. The thermocouple is used in conjunction with the configuration module temperature sensor to compensate for temperature probe errors resulting from the dissimilar metals at the pin contacts.

1. Crimp pins, item 2, onto each of the thermocouple wires, item 1. Ensure that pre-stripped wire length is 1/8" prior to crimping.
2. Insert newly crimped pins and wires into the appropriate connector housing location, item 4, as specified by King Air 200/B200 Wiring Diagram, listed in Table 1-2.
3. Place thermocouple body, item 1, onto the backshell boss, item 5. Place the thermocouple as shown in Figure 6-4 so that the wires exit towards the bottom of the backshell.
4. Fasten thermocouple tightly to backshell using the provided screw, item 3.
5. Fasten cover, item 6, to backshell using screws, item 7.
6. Continue to Section 7.4.1 and verify that the ITT indications are valid on the MFD.

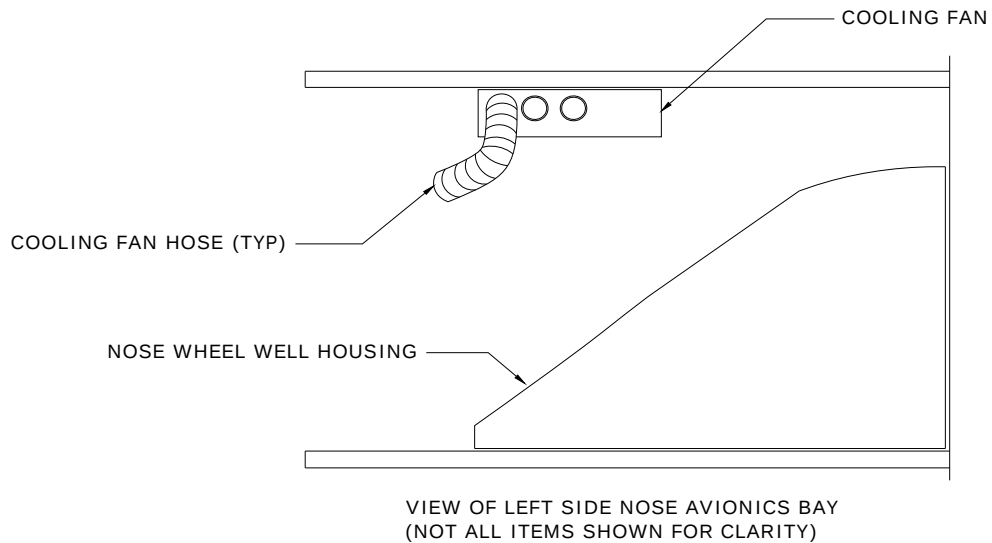
**Figure 6-5, GIA Cooling Fan Installation**  
Configuration applicable to MDL 005-00421-00 Rev. 15 or previous FAA-approved revisions

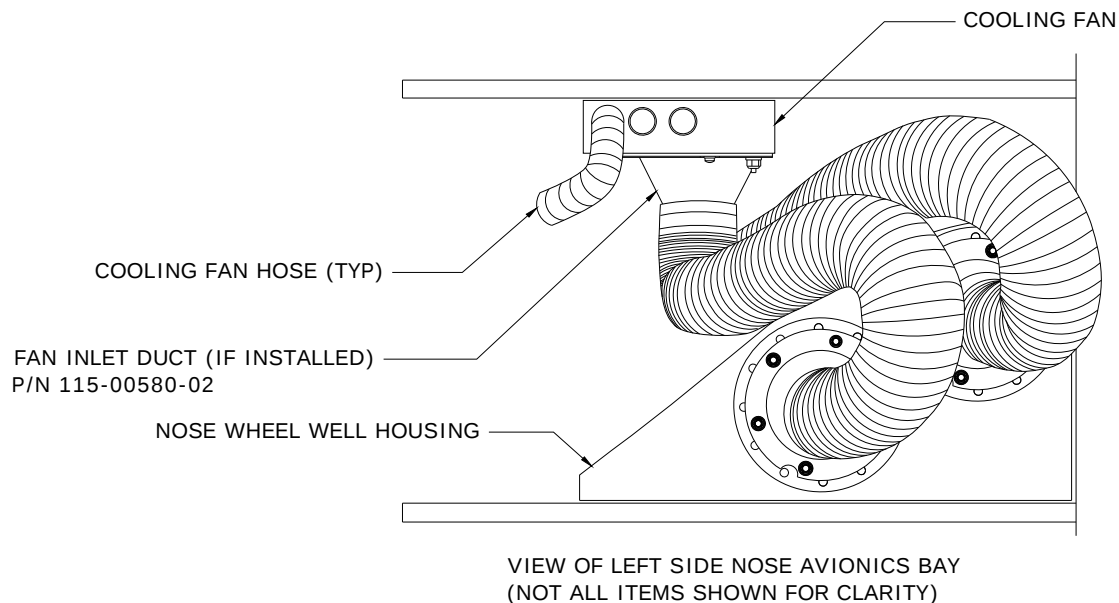
**Figure 6-6, GIA Cooling Fan Inlet Duct Installation**  
Configuration applicable to MDL 005-00421-00 Rev. 16 or later FAA-approved revisions, or modified per Garmin Service Bulletin 1375

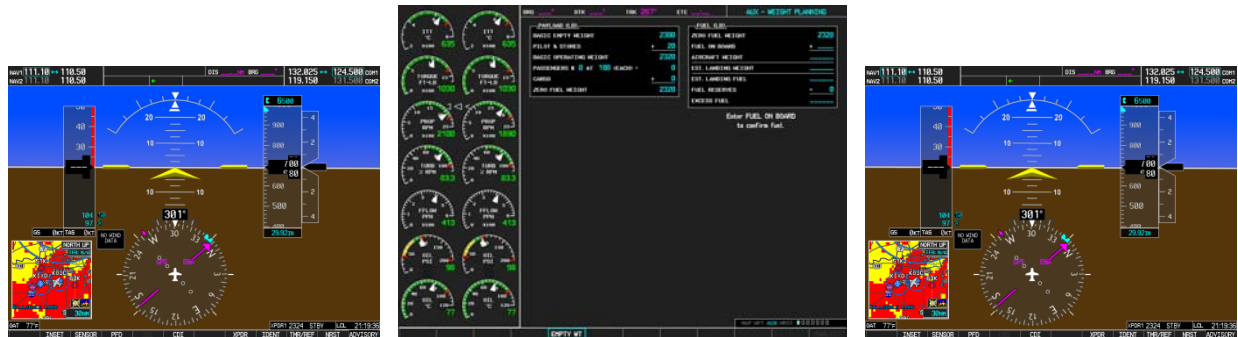
Figure 7-1, G1000 Normal Mode Check

1. Allow displays to initialize for ~1 minute.
2. Check that all COM/NAV display fields are valid in the top corners of both PFDs.
3. Check that attitude, heading, altitude, airspeed, vertical speed and OAT fields are valid within 2 minutes of power up on both PFDs.
4. Press the SENSOR softkey on each PFD and switch between ADC1 and ADC2. Verify that data from both GDC air data computers is valid on both displays.
5. Press the SENSOR softkey on each PFD and switch between AHRS1 and AHRS2. Verify that data from both GRS 77s/7800s is valid on both displays.
6. Check that the engine instrument fields are valid on the MFD.

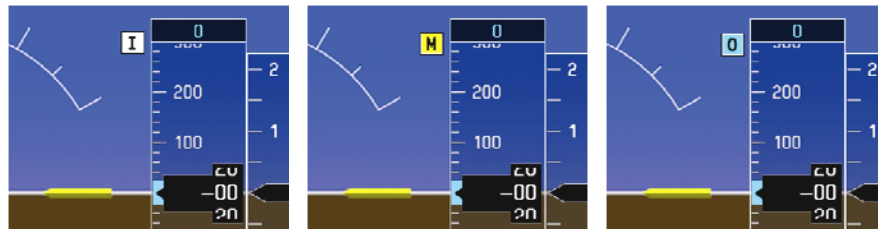
**Figure 7-2, Marker Beacon Symbology**

1. Using a ramp tester, simulate the outer marker, middle marker and inner marker signals by following the test equipment manufacturer's instructions. Verify that each marker audio signal is present over the pilot and co-pilot headphones and speaker.
2. Verify that the outer, middle, and inner annunciations appear on PFD 1 and PFD 2 when the corresponding signal is applied. Marker beacon annunciations appear at the upper left corner of the altitude indicator on the PFD (Figure 7-2). Operate the MKR MUTE key on the #1 and #2 GMA 1347D and ensure that the audio signal is muted.

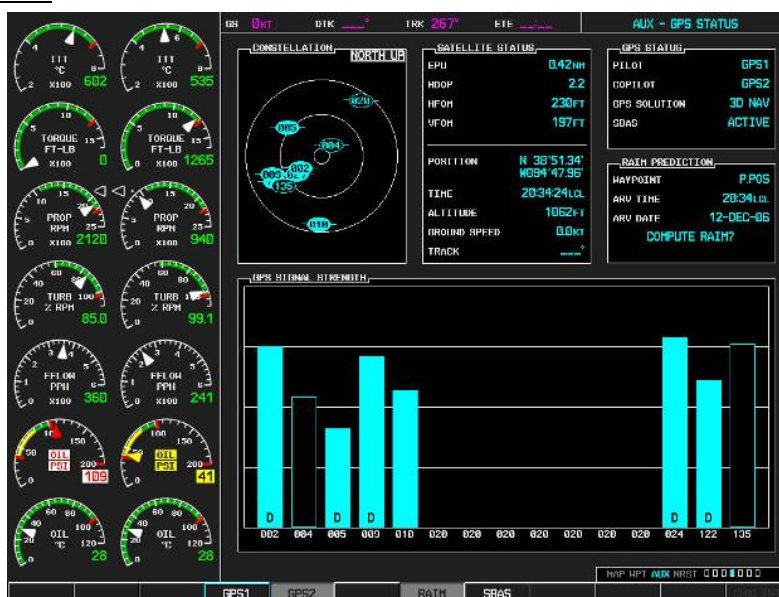
Figure 7-3, AUX – GPS STATUS Page (MFD)

The GIA 63W units should normally acquire a GPS navigation solution within 5 to 10 minutes of startup, provided the aircraft is outside (or indoors with a GPS repeater). Select the GPS STATUS page on the MFD (4th page in AUX group). Two softkeys on the bottom of the display allow the user to toggle between GPS 1 and GPS 2. Verify that both receivers show 3D DIFF NAV on the MFD.

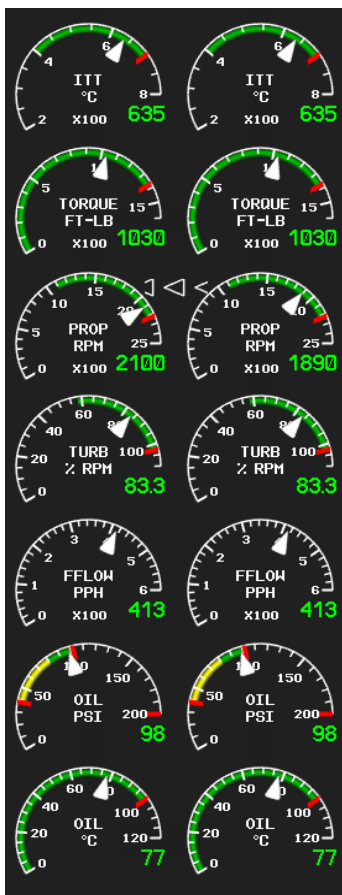
**Figure 7-4, Normal Engine Instrument Markings (MFD)**

In general, verify all engine and system instruments show valid static normal values and markings, with no red Xs or erratic indications. Reference Figure 7-4 for normal engine instrument markings (figure may not reflect actual aircraft installation). If necessary, reference Sections 0, 7.4.3 and 7.4.4 for additional tests to verify instrument readings.

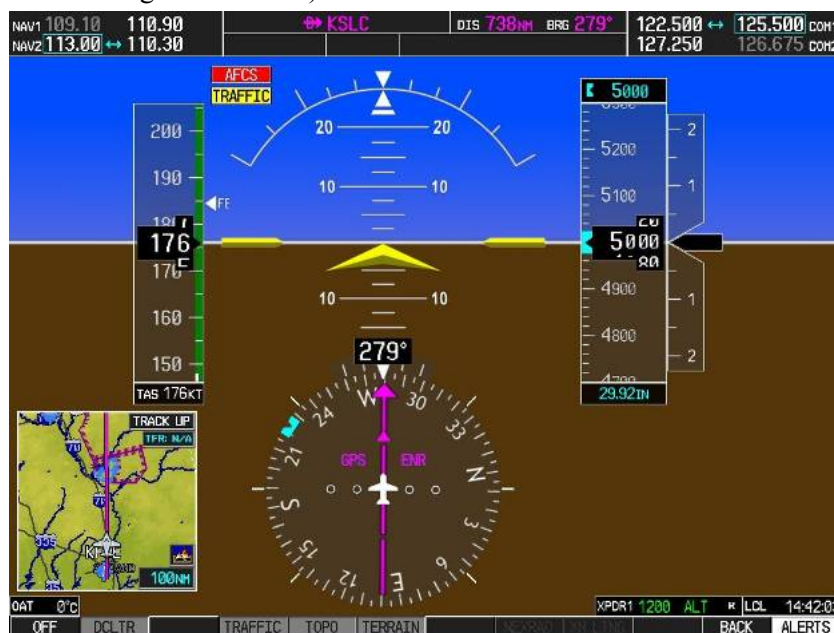
Figure 7-7, Normal Mode AHRS Check

The aircraft can now be taxied back and the engine can be shut down for final testing. Restart the displays in normal mode to conduct final system checks. When the PFDs power up in normal mode, the AHRS attitude and heading information displayed should become valid within 1 minute of power-up, as shown in Figure 7-7 (provided both GPS receivers have a valid position; if GPS is unavailable, AHRS initialization may take as long as 2 minutes).

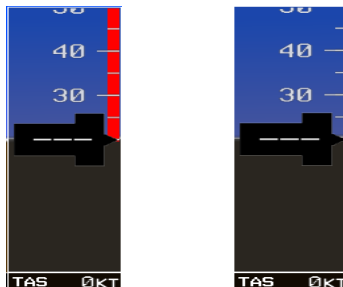
**Figure 7-8, Low Speed Awareness Band Symbolization**

5. Place the airplane on jacks (Ref. King Air 200 Series Maintenance Manual Chapter 7-00-00) with the wheels clear of the ground.
6. Verify there are no WOW INVALID or WOW FAULT messages. Refer to Section 5.3 to troubleshoot messages.
7. Verify the Low Speed Awareness band (red band) appears at the low end of the Air Speed Tape on the PFD1 and PFD2 (see Figure 7-8.)
8. Remove airplane from jacks.

1. Ensure aircraft is positioned with weight on wheels.
2. Apply external power to the aircraft. Set BATT and AVIONICS MASTER switches to ON and wait for all aircraft and avionics systems to complete their initialization and begin operating normally.
3. Verify there are no WOW INVALID or WOW FAULT messages. Refer to Section 5.3 to troubleshoot messages.
4. Verify the Low Speed Awareness band (red band) is NOT displayed on the PFD1 and PFD2 airspeed tapes (see Figure 7-8.)

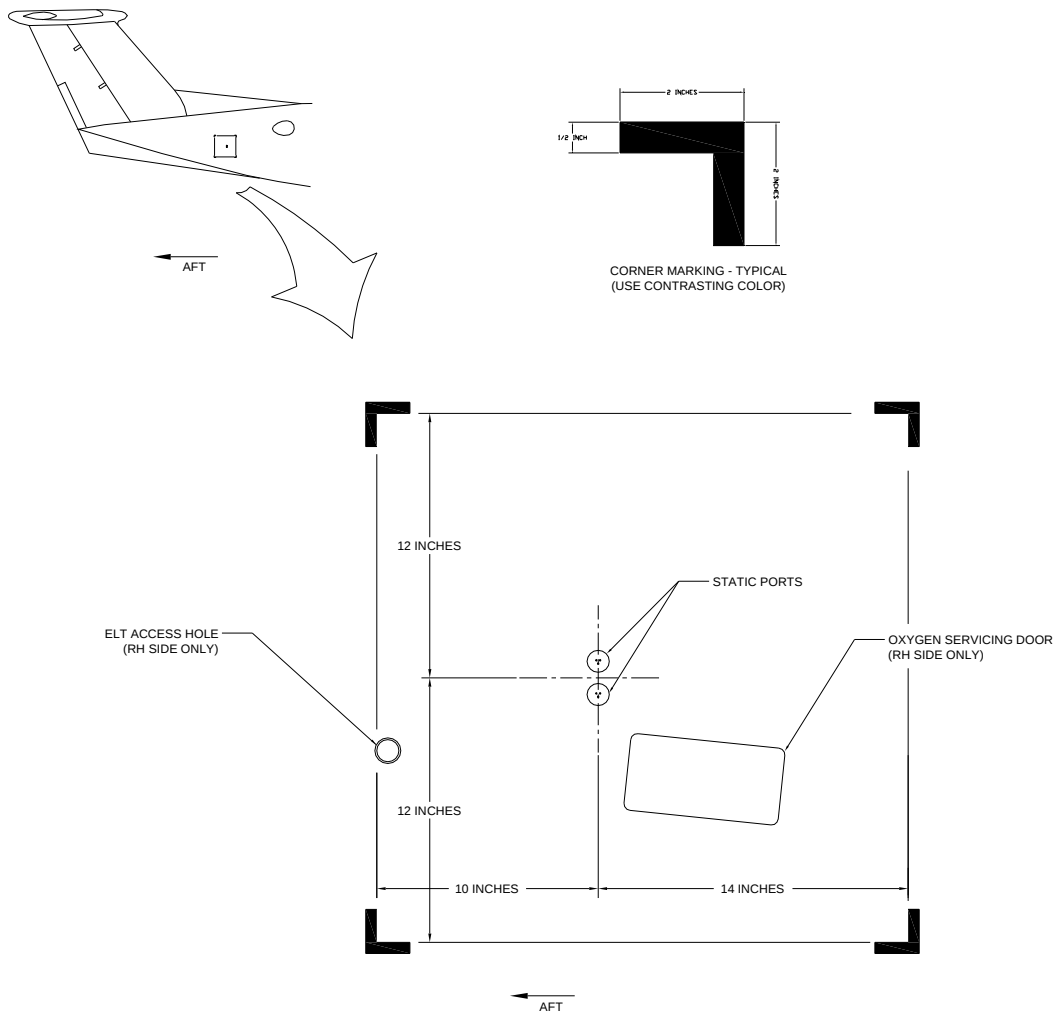
**Figure 7-9, RVSM Critical Region**

The RVSM critical region is a 24 x 24 inch area around the static ports on both sides of the airplane. The corners of the RVSM critical region are to be marked on the aircraft with placards or paint of a contrasting color (see Figure 7-9.) The RVSM critical region must meet the following visual inspection criteria:

1. The fuselage skin must be free from damage. All skin repairs within the RVSM critical region must be flush (no external doublers). If any damage is found, the area must be repaired. Locations of existing protruding head rivets in frames and skin laps are acceptable.
2. The paint (including stripes) must be uniform and smooth. Remove any paint blisters or flaking and sand smooth. Any decals or placards must be flush with no peeling edges.
3. The static ports must be free from any corrosion, elongation of holes, deformation or obstructions. If any damage is found, replace the static ports.
4. The oxygen servicing door on the right hand side must close approximately flush with the fuselage skin and be free from damage or deformation. The ELT access hole cover on the right hand side must be in place.

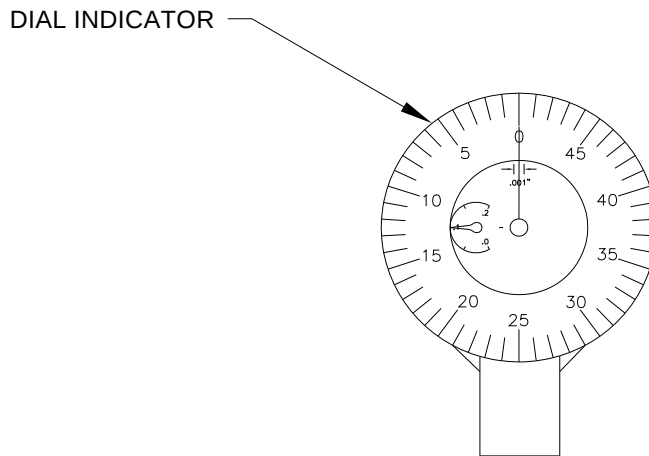
**Figure 7-10, Dial Indicator**

1. Make sure the dial indicator reads negative when the plunger is pressed and positive when the plunger is free.
2. Place the gauging assembly on a flat surface (gauge block or equivalent.)
3. Ensure the smaller needle is at approximately (.1).
4. Rotate the dial indicator to set the large needle at (0) as shown in Figure 7-10.

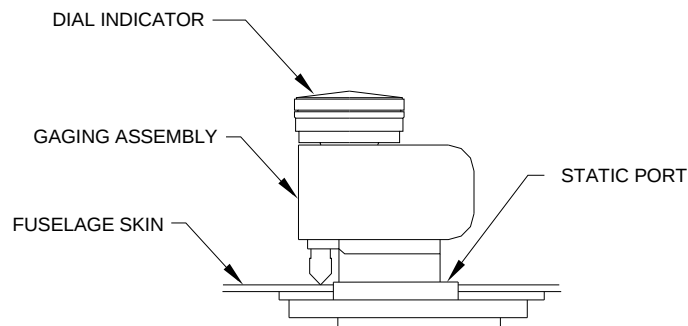
**Figure 7-11, Static Port Measurement**

1. Wipe the surface of static ports clean with isopropyl alcohol.
2. Place the gauging assembly onto the static port surface as shown in Figure 7-11.

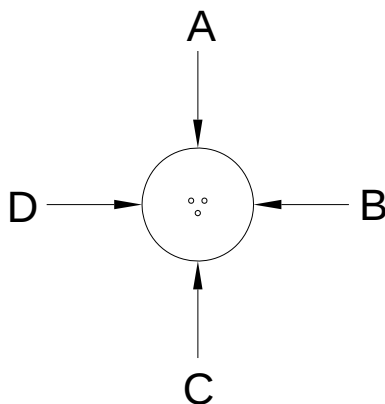
**Figure 7-12, Static Port Measurement locations**

The static port measurements are obtained at four locations on each static port as shown in Figure 7-12. These measurements are used to find an AVERAGE and ANGLE for each of the four static ports. The AVERAGE is calculated by adding the four measurements and dividing the total by 4. The ANGLE is calculated by subtracting the minimum measurement from the maximum measurement. The calculated AVERAGE and ANGLE for each static port must fall within the ranges shown in Figure 7-13.

3. For each static port, measure the static port height at the A, B, C and D locations as shown in Figure 7-12. Record the measurements in the measurement log, Figure 7-13.

7. Ensure the ANGLE for each static port is within tolerance (0.000 to +0.026 inch.) If it is not, remove and reinstall the static ports as necessary to meet the tolerance.

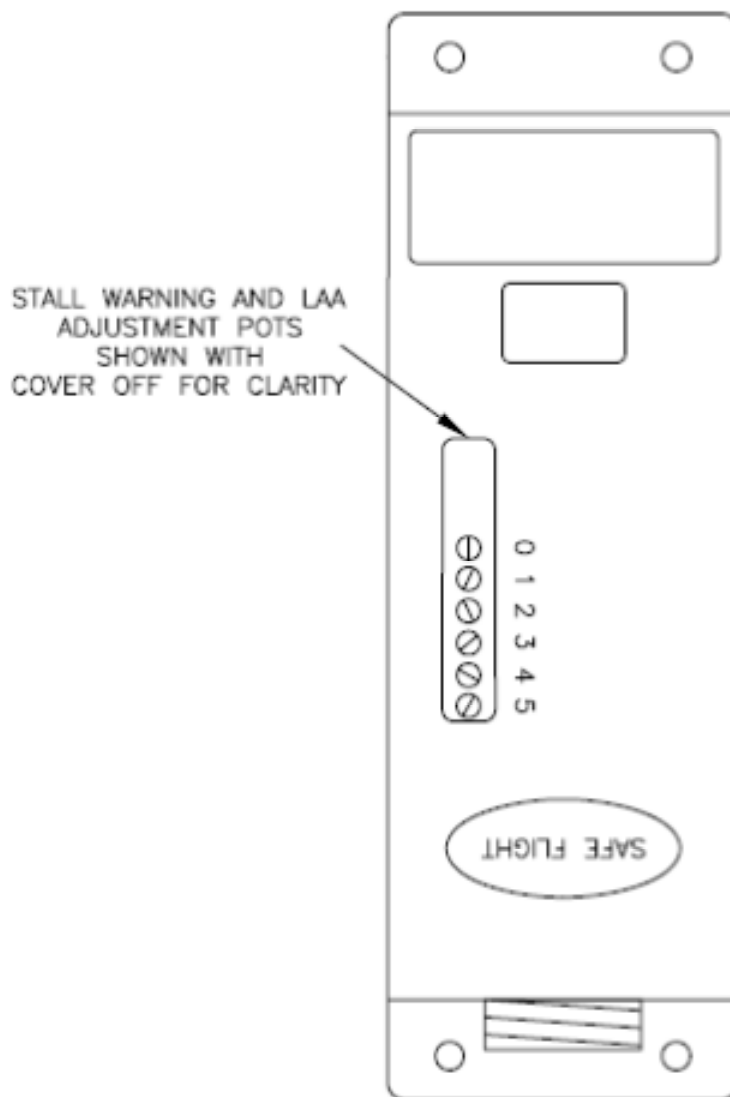
**Figure 7-14, C-05606-1 Lift Computer**

VIEW LOOKING DOWN  
SAFE FLIGHT LIFT COMPUTER  
P/N C-05606-1  
(NOT TO SCALE)

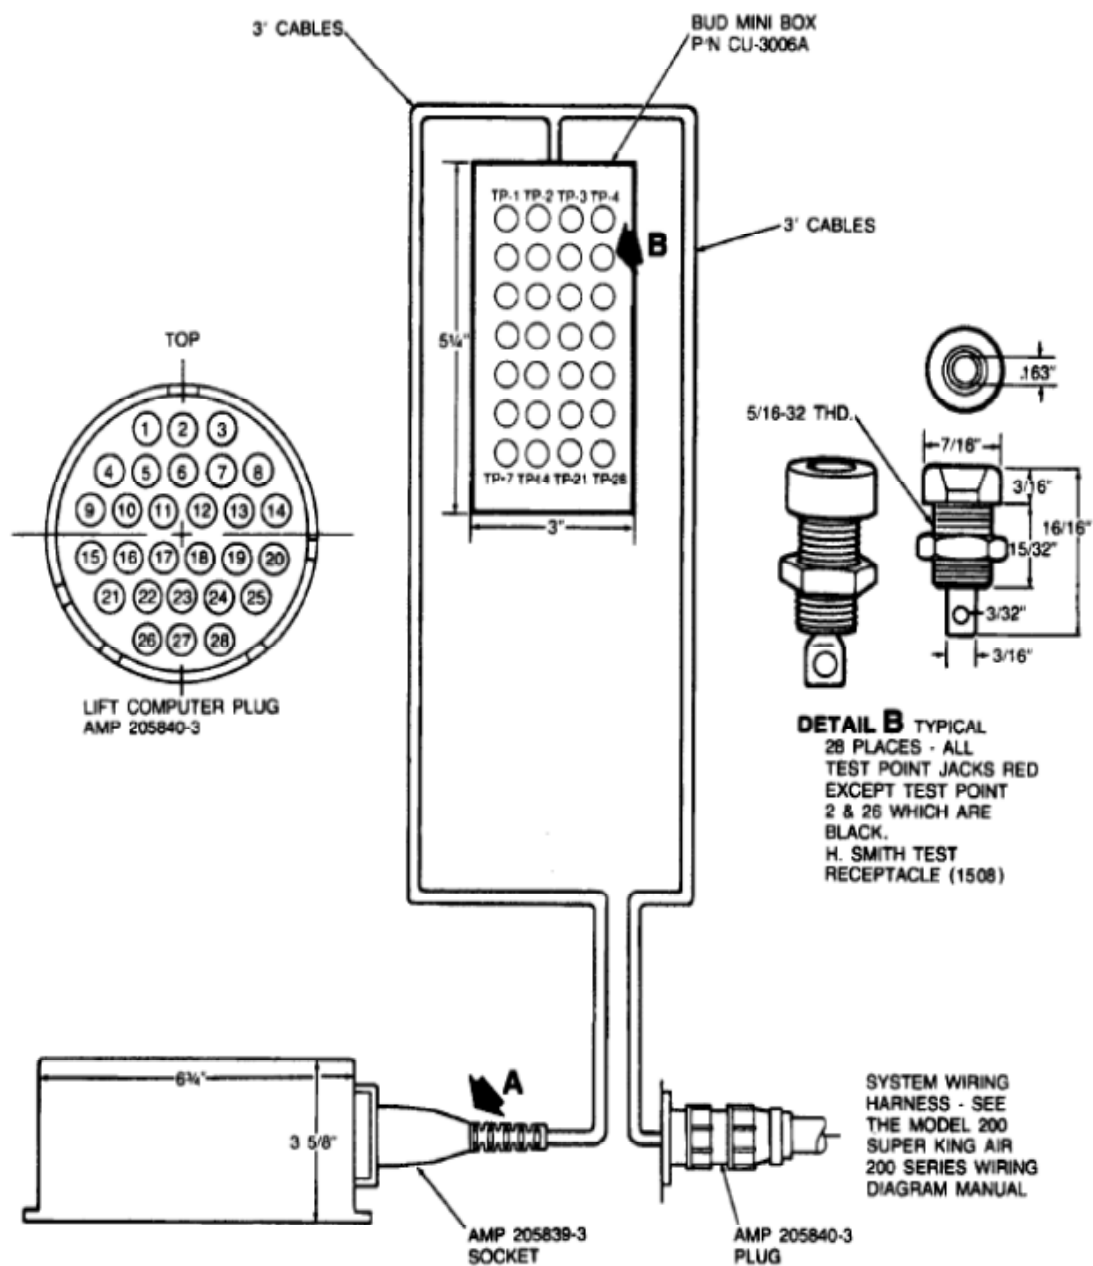
Figure 7-15, Breakout Box

1. Gain access to the stall warning computer.
2. Connect the breakout box (P/N SK100360 or equivalent) between the lift computer and the airplane wiring harness (see Figure 7-15).
3. Make sure that the stall warning heat system is turned OFF.
4. Remove the potentiometer access cover plate from the lift computer.
5. Simulate an in-flight condition as follows: Bypass the landing gear safety switch by connecting an electrical ground to TP 7 of the breakout box. This is best accomplished by placing a jumper between TP 2 and TP 7 of the breakout box.

1. Connect the SK100360 breakout box between the Safe Flight P/N C-05606-1 lift computer and the mating aircraft harness (see Figure 7-15).
2. Make sure the stall warning heater system is turned OFF.
3. Remove the potentiometer access cover plate from the lift computer.
4. Simulate an in-flight condition as follows: Bypass the landing gear safety switch by connecting an electrical ground to TP7 of the breakout box. This is best accomplished by placing a jumper between TP2 and TP7 of the breakout box.

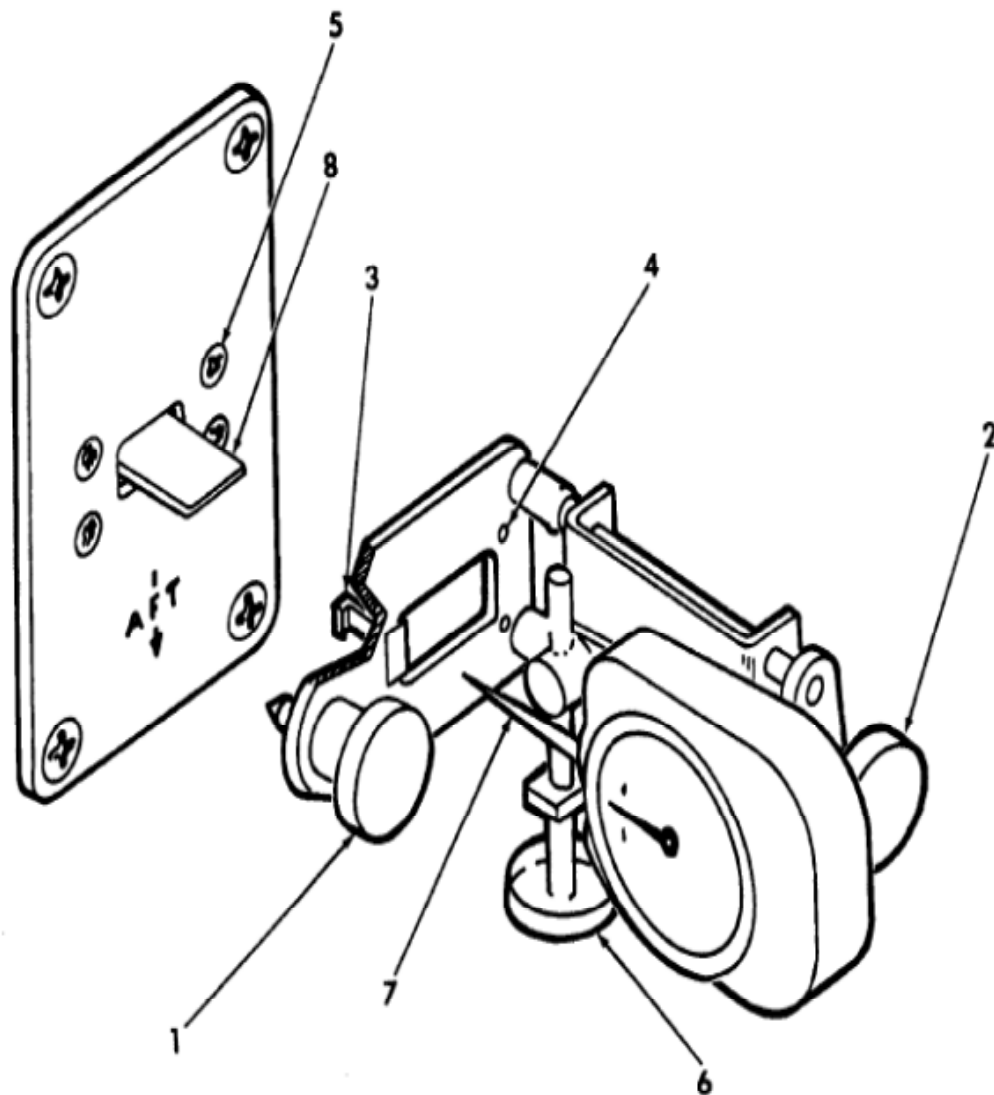
1. Insert positioner anchor tab (3) into vane opening.
2. Hook anchor tab (3) onto the mounting plate.
3. Keeping anchor tab engaged, shift positioner until cone points (4) enter recesses in the screw heads (5).
4. Turn screw (1) counterclockwise until knob clutch slips.
5. Turn screws (2) and (6) as required to bring gage pressure arm (7) to bear on surface of vane (8) within 1/32" of tip.
6. Apply pressure to aft surface of vane (8) for negative (-) tip grams and forward surface for positive (+) tip grams.
7. Turn screw (6) to adjust force (tip grams) as required.

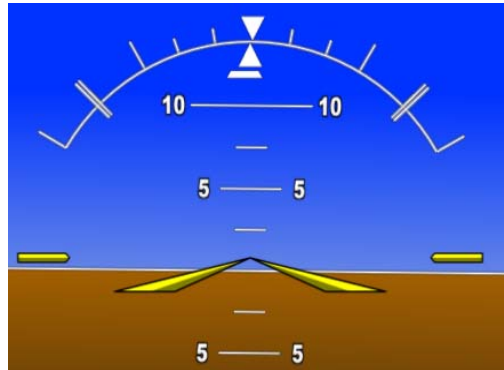
9. Verify on PFD 1 and PFD 2 that there are no “ESP FAIL”, “ESP OFF”, or “ESP DEGRADE” alert messages.
10. Cover both GPS1 and GPS2 antennas.
11. Verify on PFD 1 and PFD 2 the ESP Roll Indices are displayed at 45° on the roll indicator on the Attitude Display.

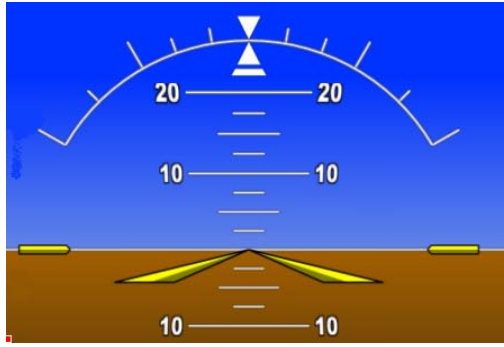
16. Verify on PFD 1 and PFD 2 the ESP Roll Indices are not displayed at 45° on the roll indicator on the Attitude Display.

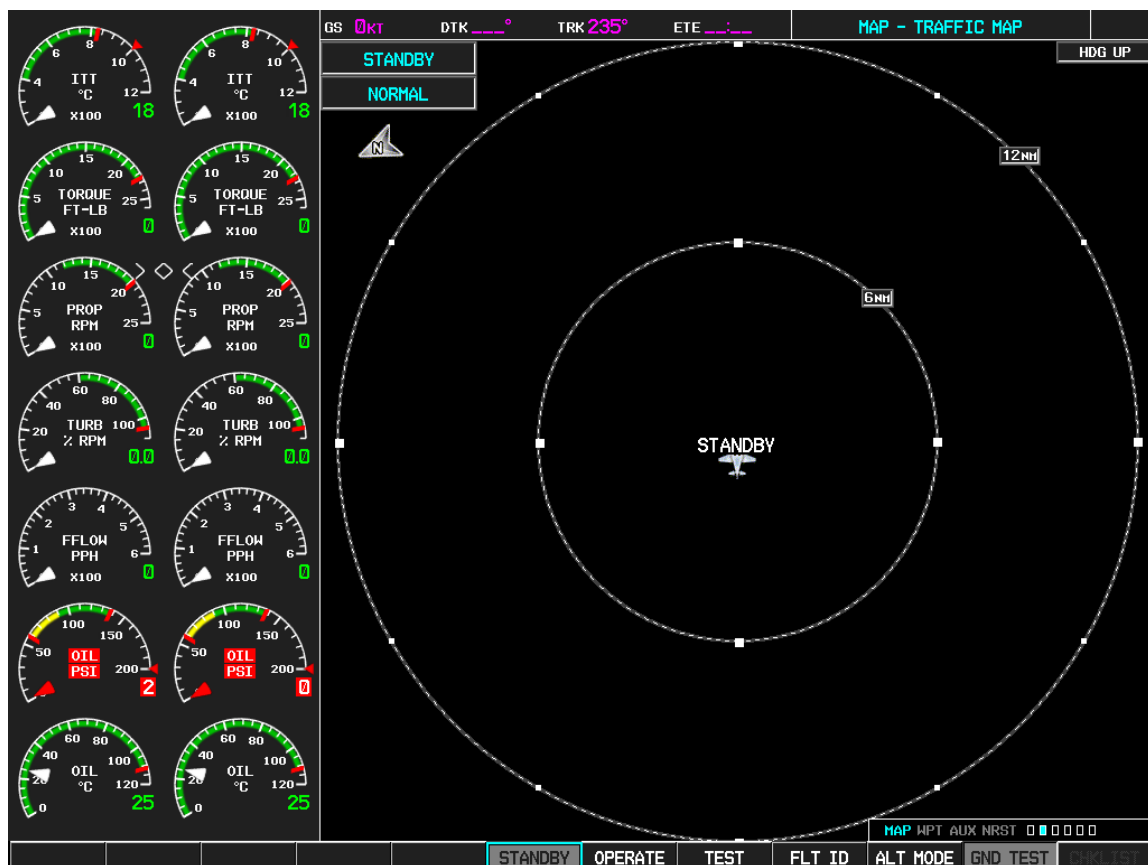
Figure 7-17, GTS 820/850 or GTS Processor GND TEST softkey

To perform these tests for the GTS 820/825/850/855 (GTS 8XX) traffic systems, the aircraft must be on the ground, the Radar Altimeter circuit breaker (if installed) must be opened prior to GTS 8XX unit power on, remain open throughout testing, and the GTS 8XX must be in Ground Test mode. For those tests with the GTS 8000 TCAS II configuration, the Radar Altimeter circuit breaker (if installed) must be engaged throughout these tests. On the MAP-TRAFFIC MAP page of the MFD, press the softkey sequence: **3, 4, 4, 3**. The **GND TEST** softkey will appear. Press the **GND TEST** softkey to activate Ground Test mode. This simulates the GTS 8XX to be airborne at 50,000 feet with a magnetic heading of 0 degrees. To exit the Ground Test mode, press the **GND TEST** softkey again.

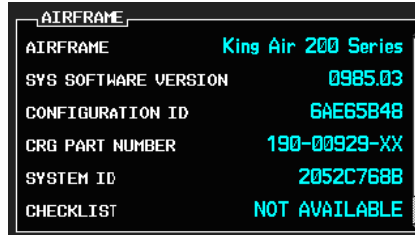
SYSTEM ID Number Location

1. Turn the large FMS knob on the MFD to select the AUX page group.
2. Turn the small FMS knob to select the SYSTEM STATUS page. Record the SYSTEM ID number shown in the AIRFRAME field. This number is unique for each G1000 system.

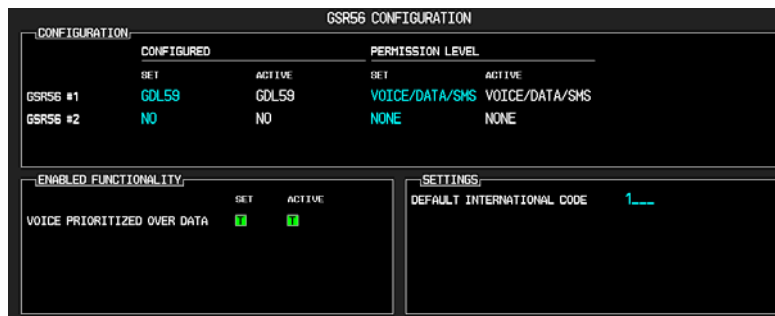
Figure 7-18, GSR56 Configuration Page

1. Power up the PFD1 in configuration mode.
2. On the PFD1, select GDL page group using the large FMS knob.
3. Using the small FMS knob select the GSR56 Configuration page. Verify the page can be displayed and information is available.

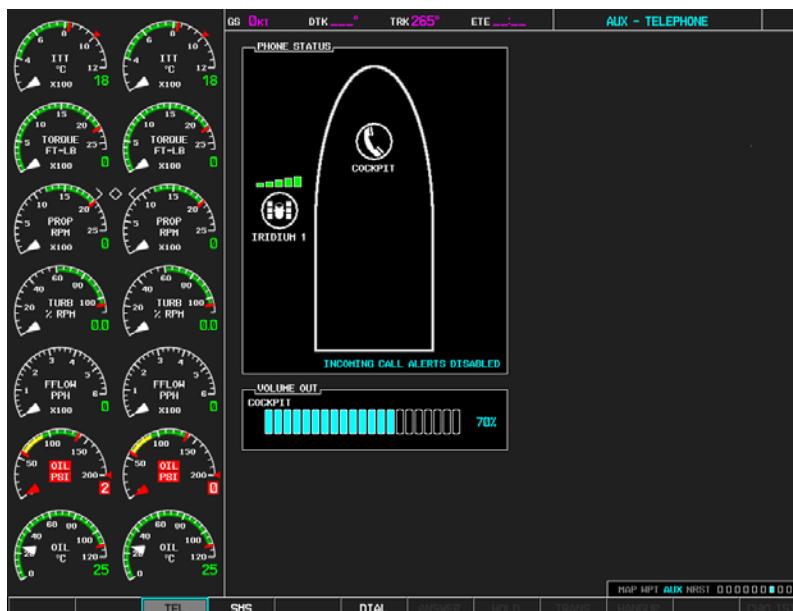
Figure 7-19, AUX-TELEPHONE page

4. Restart the G1000 System in Normal Mode.
5. Using the large FMS knob, select the AUX page group on the MFD. Using the small FMS knob, select the AUX-TELEPHONE page.
6. Ensure the system is showing Iridium signal strength (best if aircraft is outside).
7. Press **TEL** button on the pilot's GMA.
8. Press the **DIAL** softkey on the MFD.
9. Enter the test phone number in the ENTER PHONE NUMBER field using the GCU keypad.
10. Press the **ENT** key on the GCU keypad to accept the phone number.
11. Press the **ENT** key on the GCU keypad to initiate the dialing sequence.
12. When call is complete, press the **HANGUP** softkey on the AUX – TELEPHONE page on the MFD to end the call.

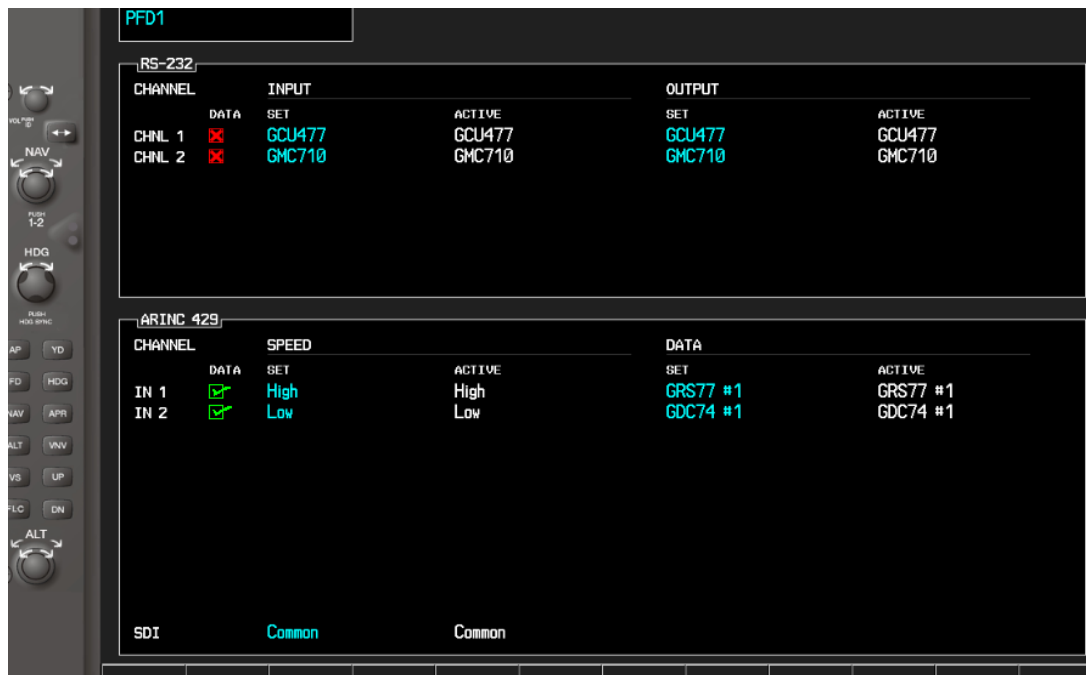
**Figure 8-1, GDU Data Verification (ARINC 429)**

1. Remove power from the displays by opening the following circuit breakers:
  - PFD1 PRI
  - PFD1 SEC
  - PFD2
  - MFD
2. Close the PFD1 PRI, PFD1 SEC, PFD2 and MFD circuit breakers while holding the ENT key on each display (far right key on MFD) until the words INITIALIZING SYSTEM appear.
3. In configuration mode, go to the GDU Page Group on PFD1.
4. On PFD1, activate the cursor and select PFD1 in the SELECT UNIT field and press ENT.
5. Observe the GRS 77 or GRS 7800 and GDC 74 DATA indicators in the ARINC 429 window.
6. Verify both indicators are GREEN, indicating the channels are receiving data as shown below:

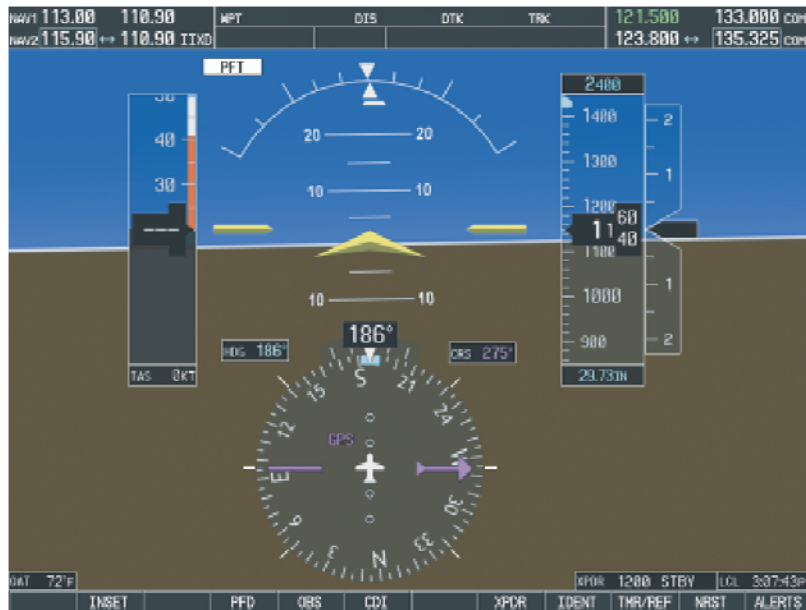
Figure 8-4, Pre-Flight Test

1. If selected ON, select the BATT and AVIONICS MASTER PWR switches and ground power unit to OFF. After 30 seconds select the ground power unit and BATT and AVIONICS MASTER PWR switches to ON. Verify the GFC 700 begins an automatic pre-flight test after AHRS and ADC parameters become valid.
2. Verify that a white 'PFT' annunciation is displayed on PFD1 and PFD2, as shown in Figure 8-4.

If the 'PFT' annunciation turns red, the test has failed. Return to Section 5 for troubleshooting.
